## BRIDGE NO. 05939

18080 - CROMWELL  
NORTH ROAD EXTENS.  
over  
COLES BROOK

Routine Inspection

6/06/2016

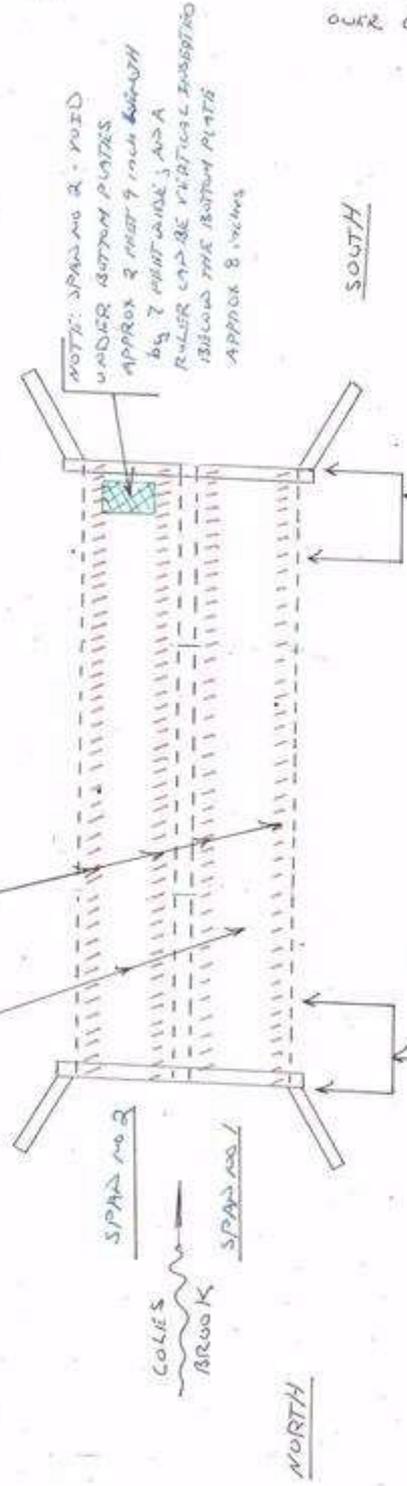
ARCH PIPE CROSS SECTION

NOTE: BOTTOM PLATES EXHIBIT AN AREA OF WEAR AND TEAR WITH PROMINENT HEAVY LAMINAR RUST WITH PROMINENT THINNING; THIS CONDITION IS FULL LENGTH OF ALL PIPE SPANS 1 & 2

NOTE: CORNER & BOTTOM PLATES EXHIBIT AN AREA OF EXTENSIVE HEAVY LAMINAR RUST WITH PROMINENT THINNING & NUMEROUS AREAS OF DELFOIDAL & MICROPITTING AS WELL AS STAIN WITH HAMMERS; THIS CONDITION IS APPROX 18 INCHES WIDE OF EACH SIDE HEAVY LAMINAR RUST

NOTE: SPAN NO 2 - VOID UNDER BOTTOM PLATES APPROX 2 FEET 9 INCH WIDE BY 2 INCH WIDE, AS A RULER CAN BE VERTICAL INSERTED BELOW THE BOTTOM PLATE APPROX 8 INCHES

NOTE: NUMEROUS RUST NODULES UP TO APPROX 6" x 4" by 3" are located at EXIST'G OUTLET - SPAN NO 1 & 2 FOR APPROX 10 FEET LENGTH OF PIPE

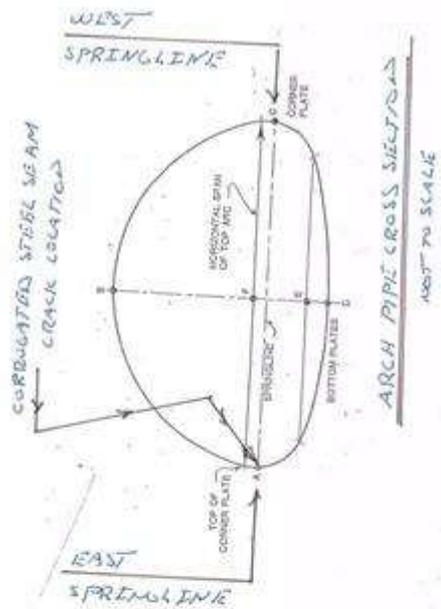
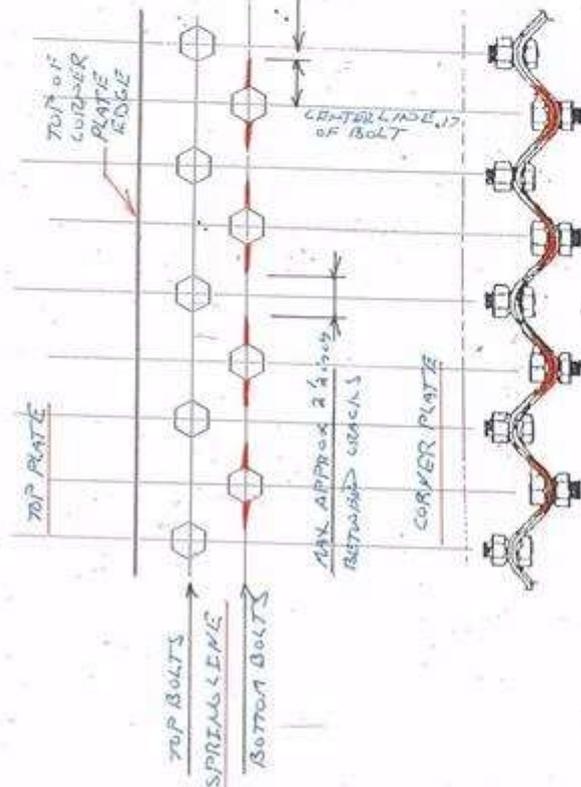
NOTE: CORRUGATED STEEL SPAN CRACKS AT BOLTLINE - SPAN NOT EAST SPRINGLINE & SPAN NOT WEST SPRINGLINE  
CRACK LENGTH VARIES APPROX 1/8 inch to 2 1/2 inch on EACH SIDE OF BOLT  
CRACK WIDTH VARIES APPROX HAIRLINE to 1/16 inch

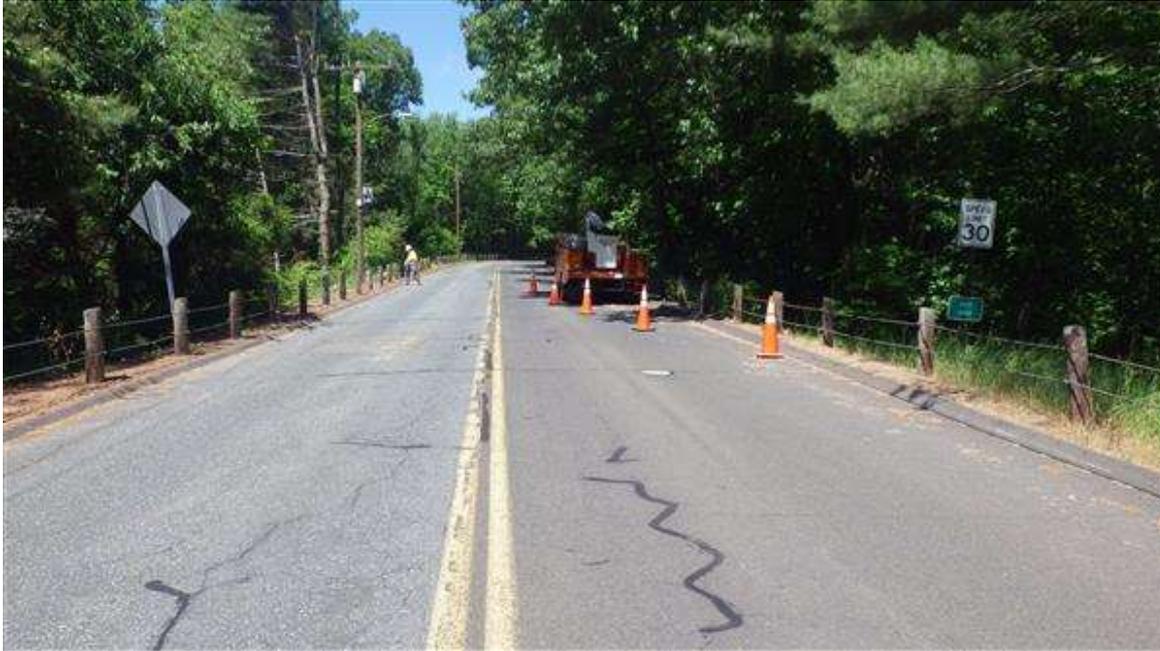
Photo Number: 1

East approach looking westbound.

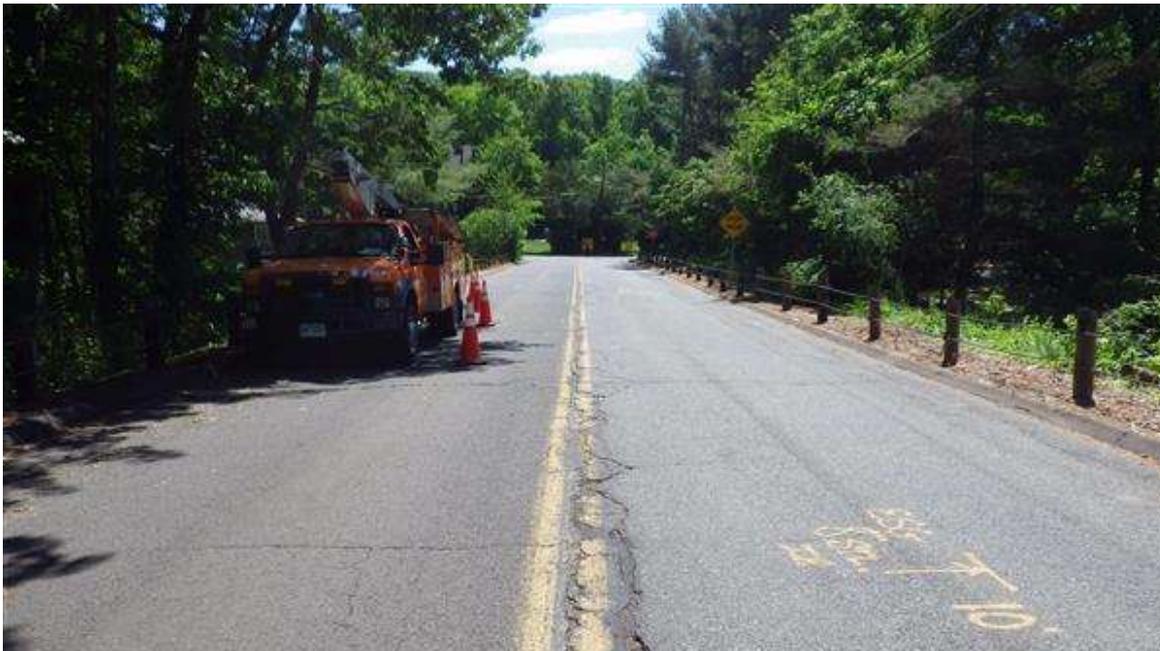
Photo Number: 2

West approach looking eastbound.

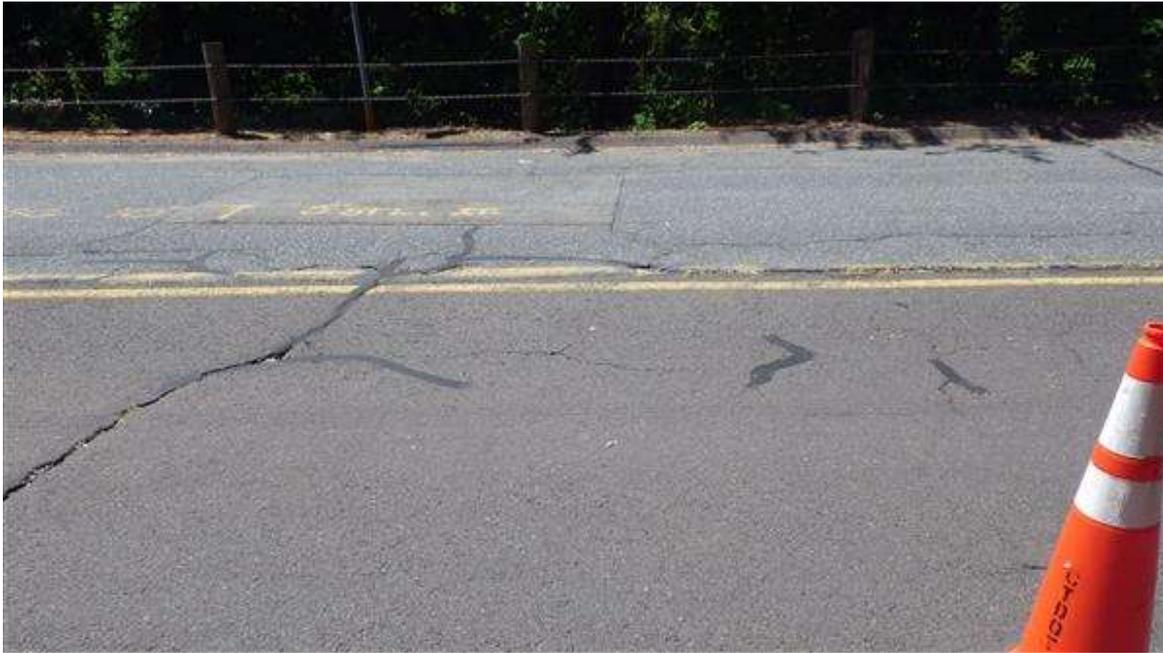
Photo Number: 3

View of the wearing surface over the structure.

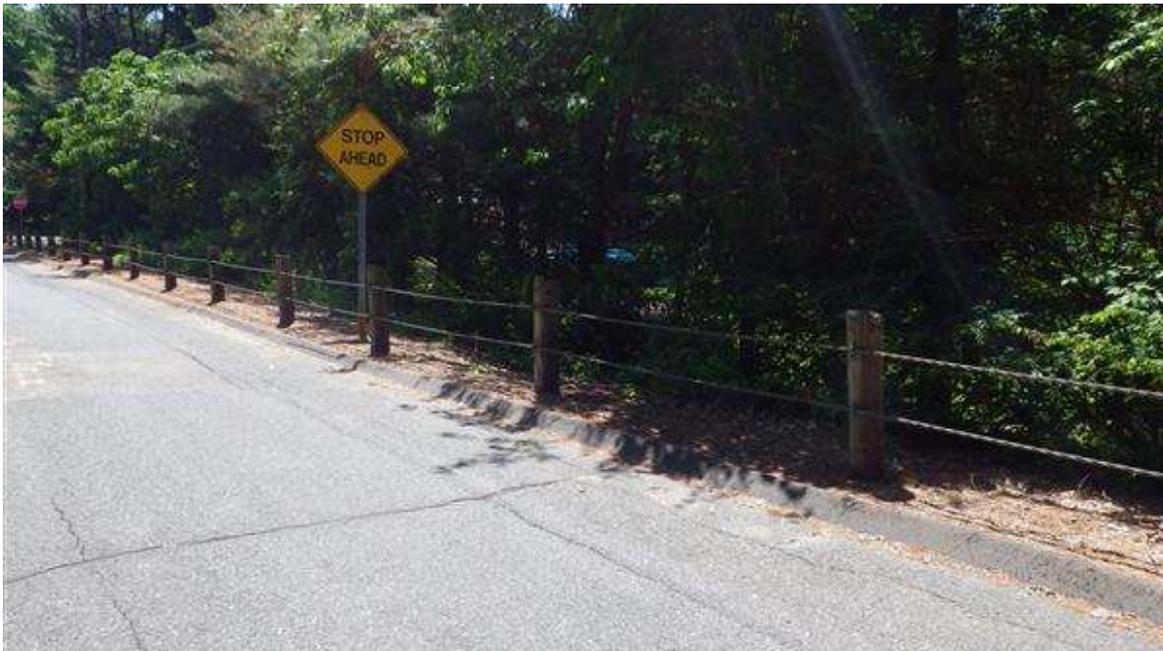
Photo Number: 4

Rail system on the south side {outlet}.

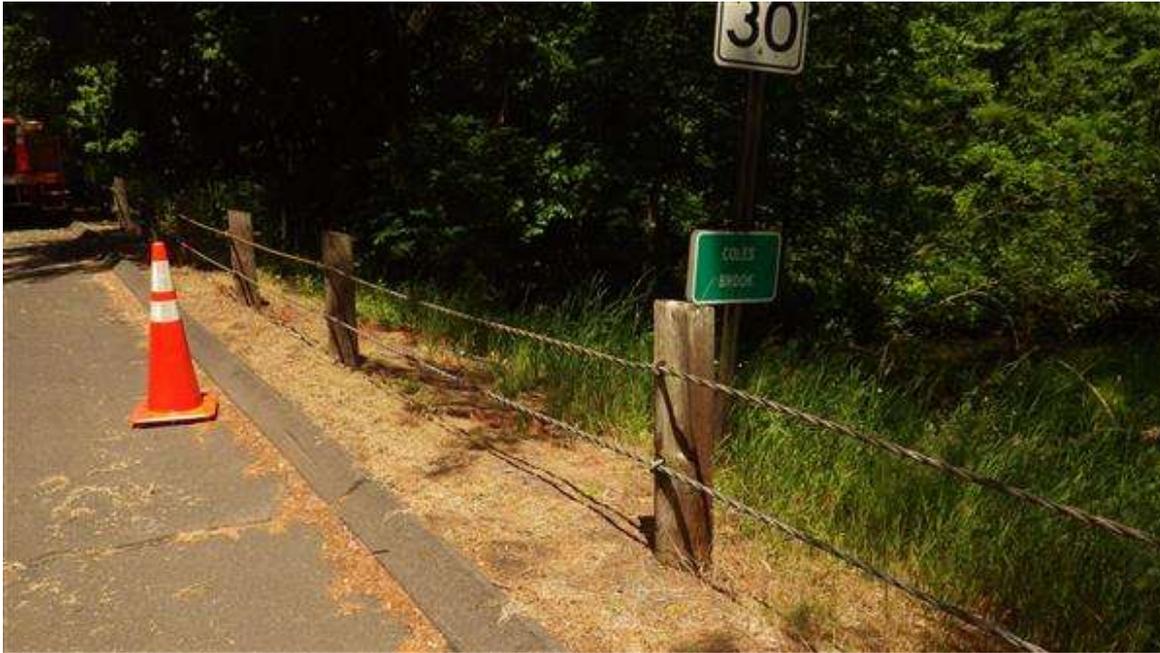
Photo Number: 5

Rail system on the north side.

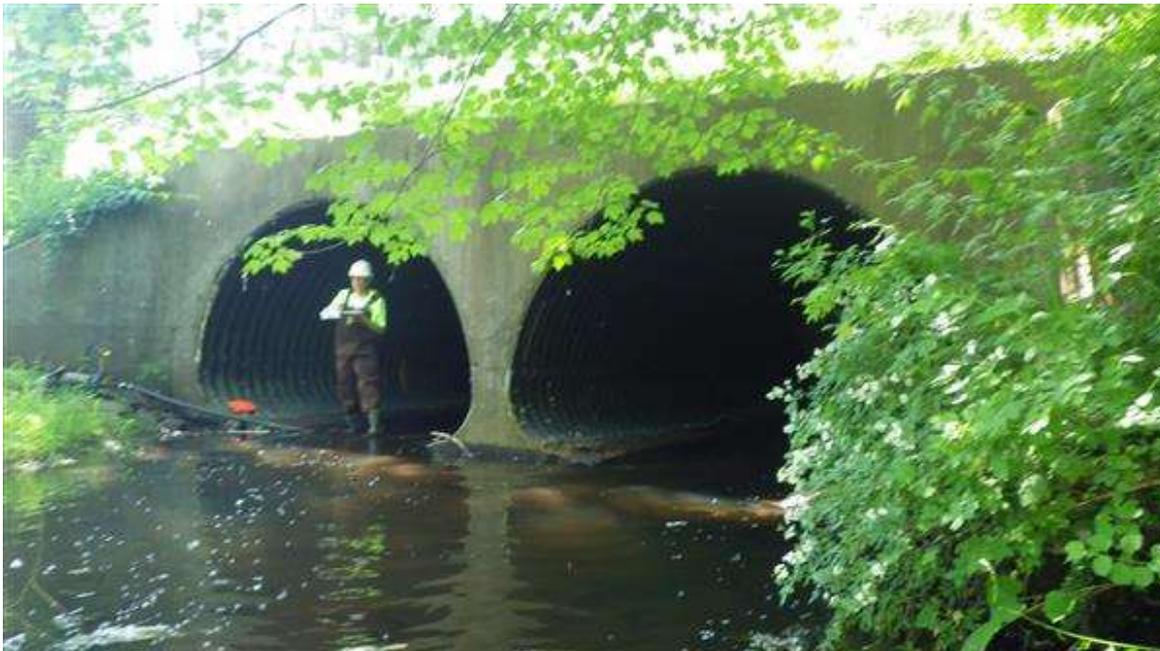
Photo Number: 6

Inlet {north} elevation.

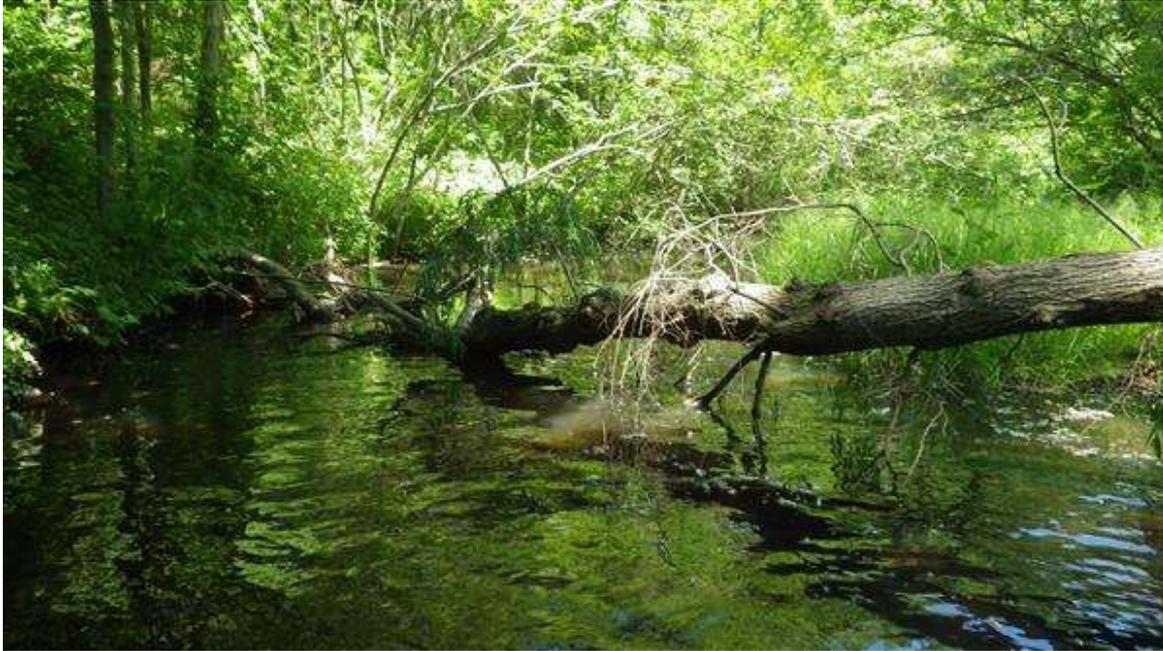
Photo Number: 7

View looking upstream, note the tree across and in the channel located +/- 25' from the structure.

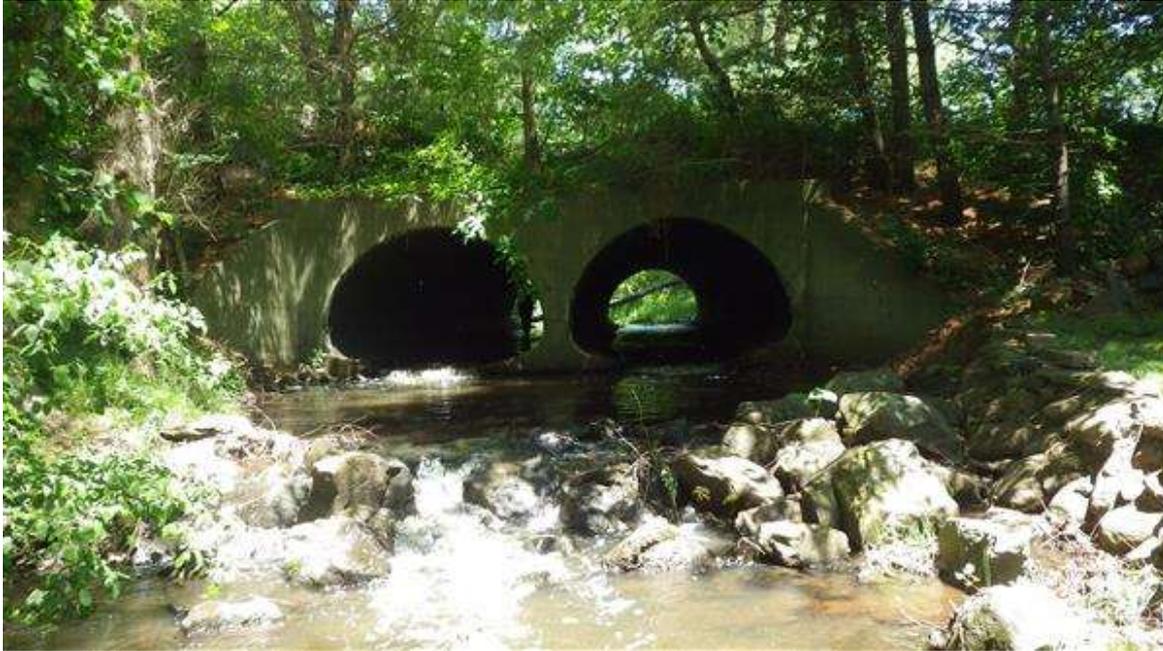
Photo Number: 9

Outlet {south} elevation.

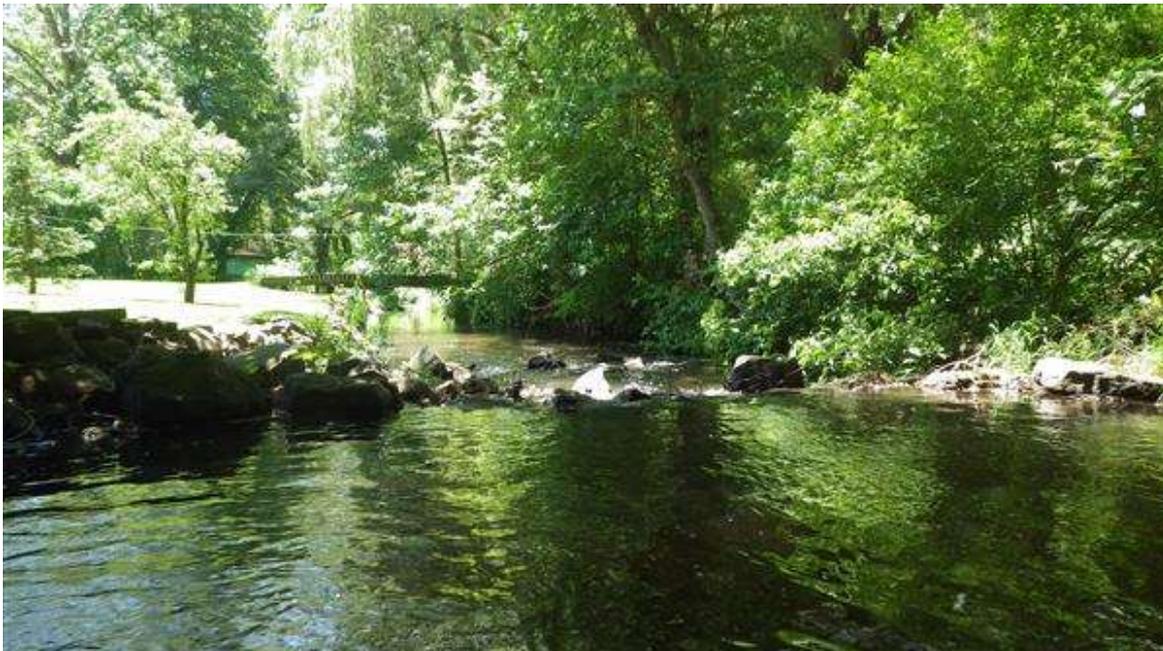
Photo Number: 10

View looking downstream.

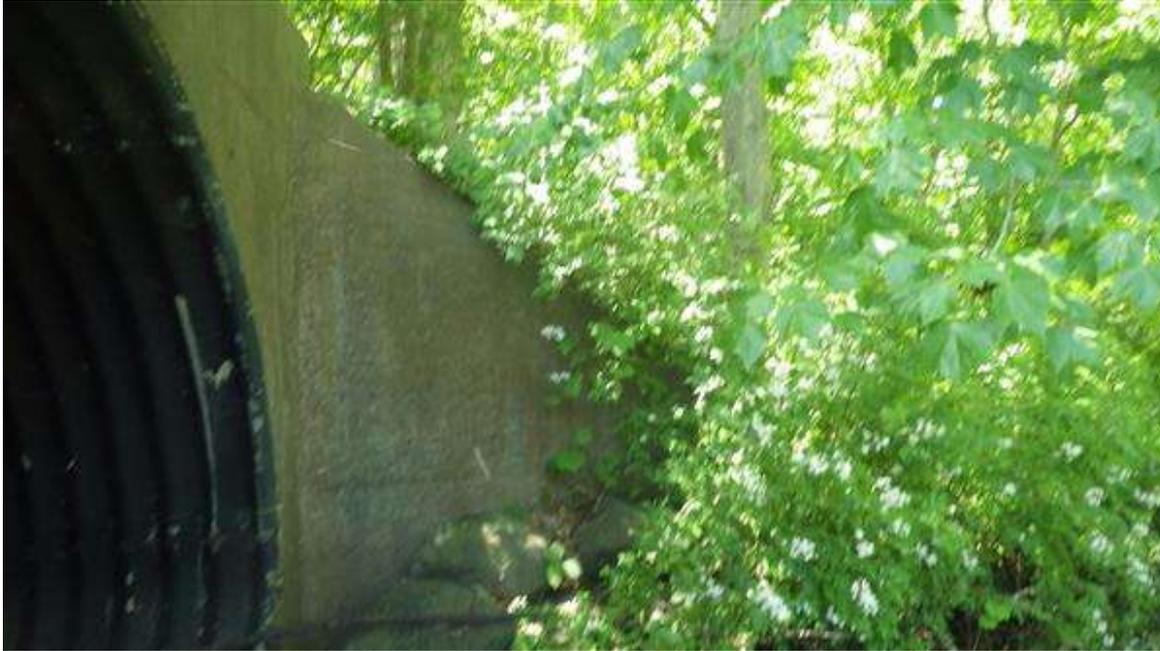
Photo Number: 11

Northwest wingwall.

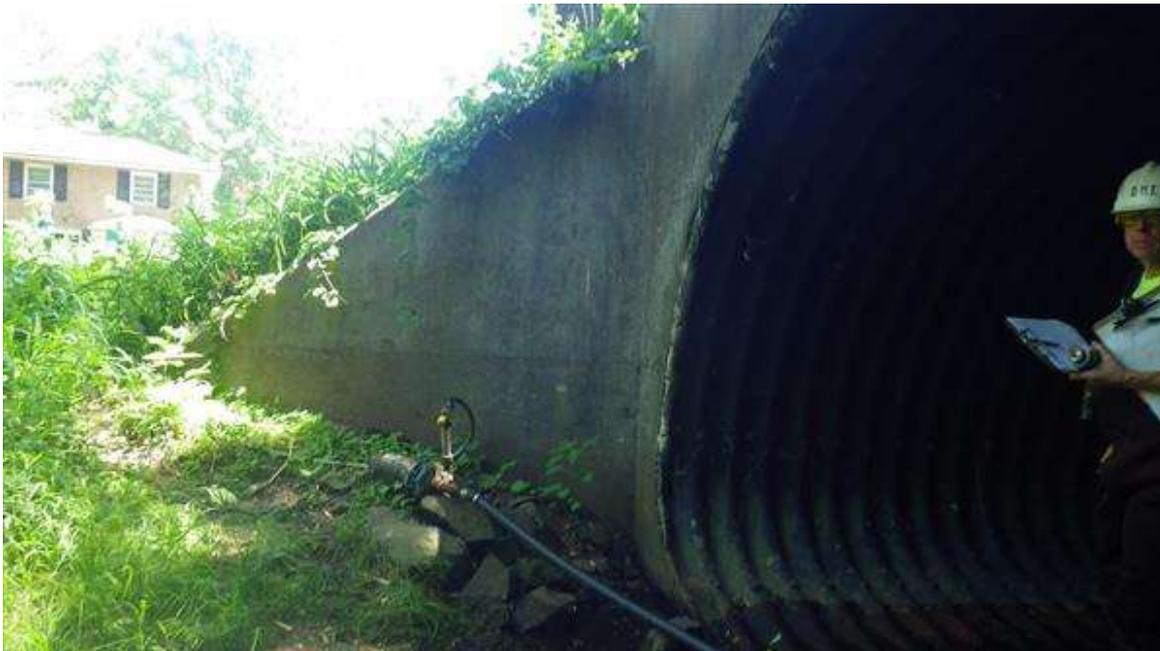
Photo Number: 12

Northeast wingwall.

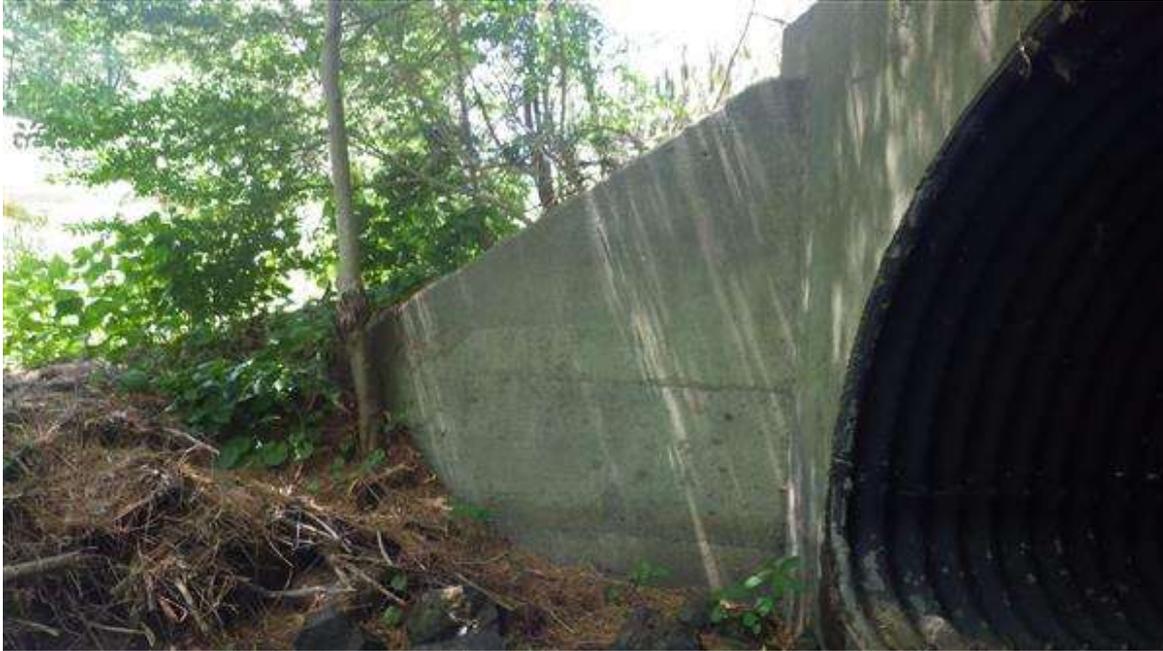
Photo Number: 13

Southwest wingwall.

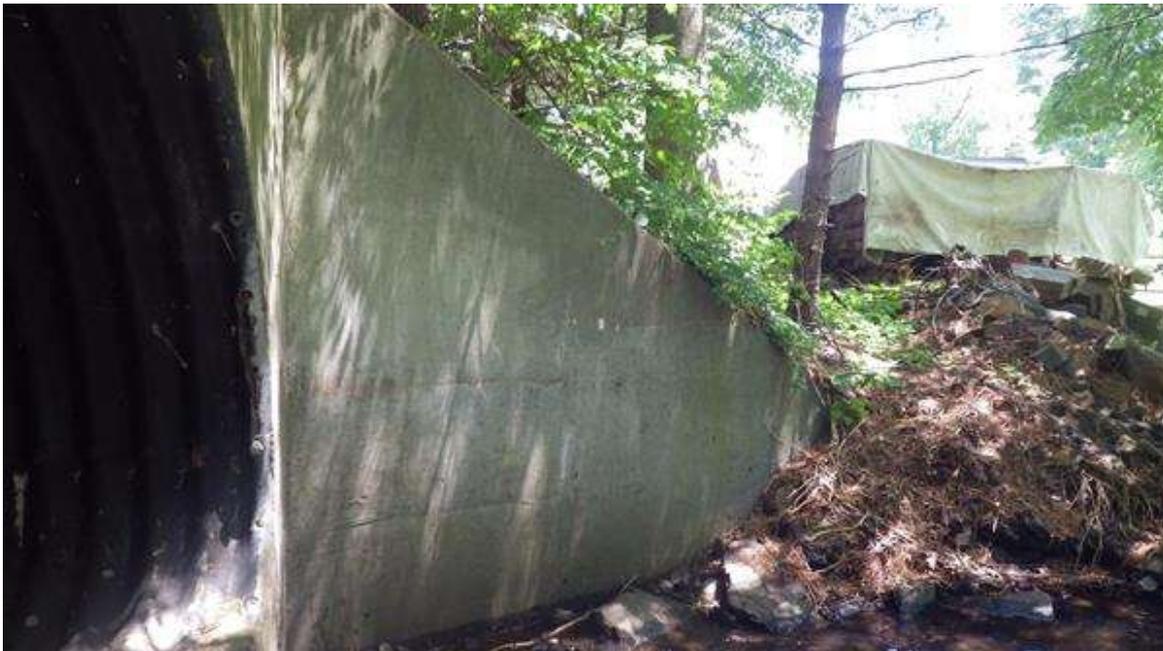
Photo Number: 14

Retaining Wall System: 7	Reinforced concrete wingwalls exhibit:  Light to Medium Scale Located Above and Below Waterline..  Southeast wingwall exhibits a horizontal hairline crack with efflorescence.
Footing: N	Not visible.

Southeast wingwall.

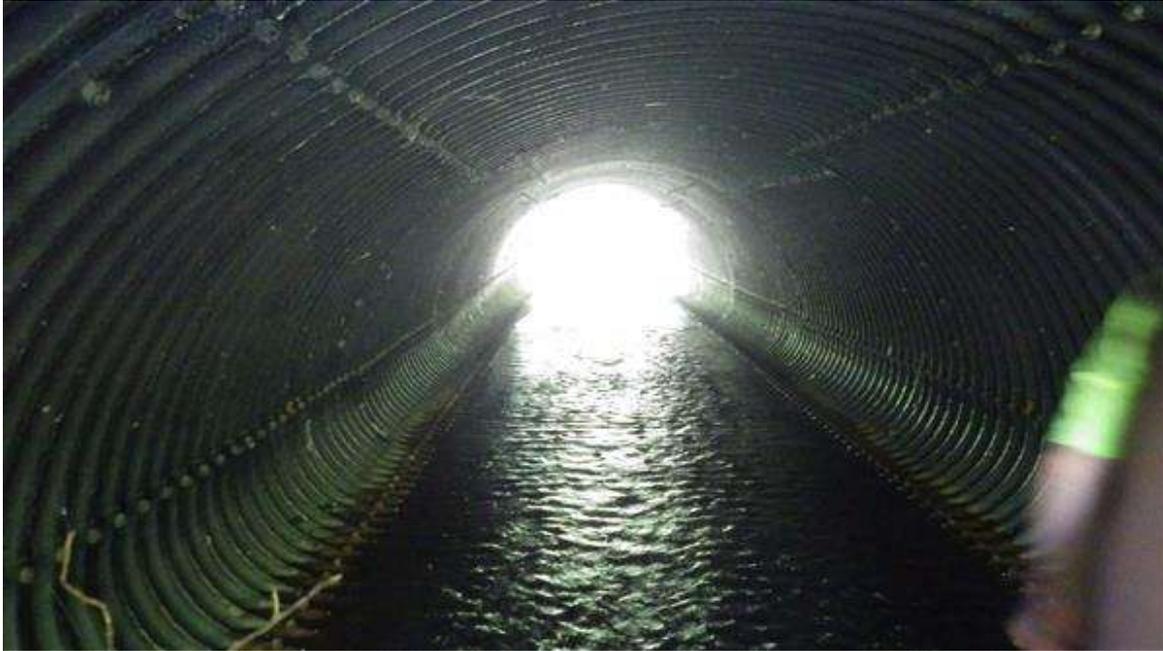
Photo Number: 15

View through cell # 1.

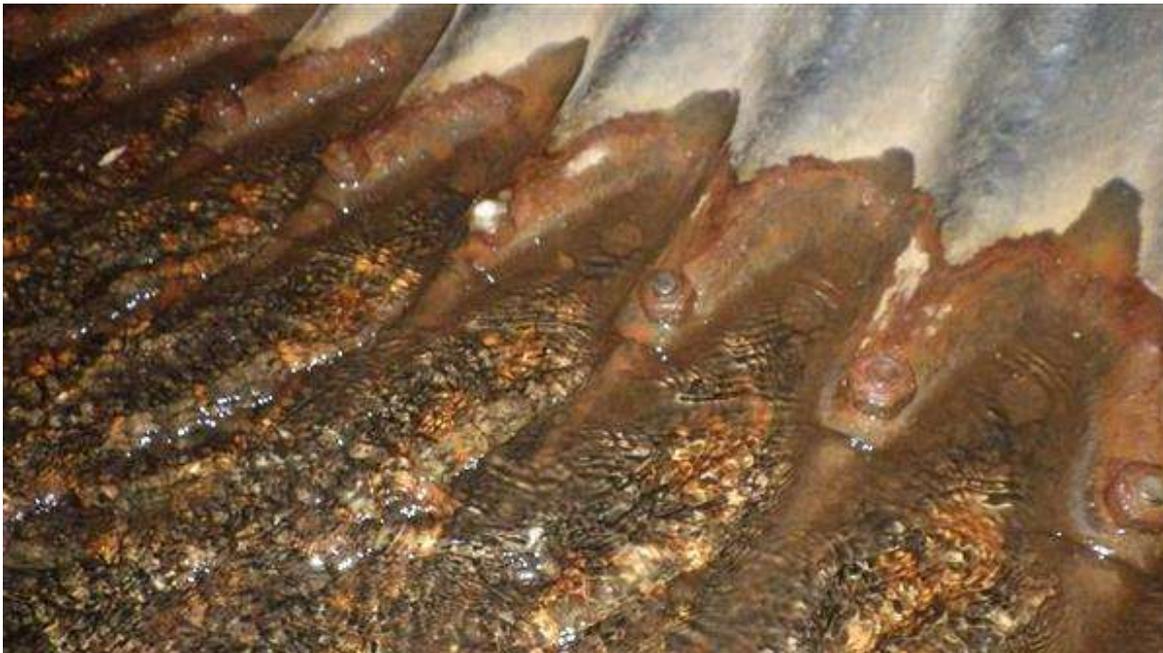
Photo Number: 16

The lower corner plates and invert plates from the outlet in 10' on both stems exhibit a 2' wide band of heavy laminar rust. Numerous perforations holes up to 6-1/2" long x 3" wide and can be probed up to 8" below the invert and up to 16" laterally. The remaining steel in this area can be easily perforated with a hammer.

Typical heavy rust conditions on the lower corner plates and invert plates.

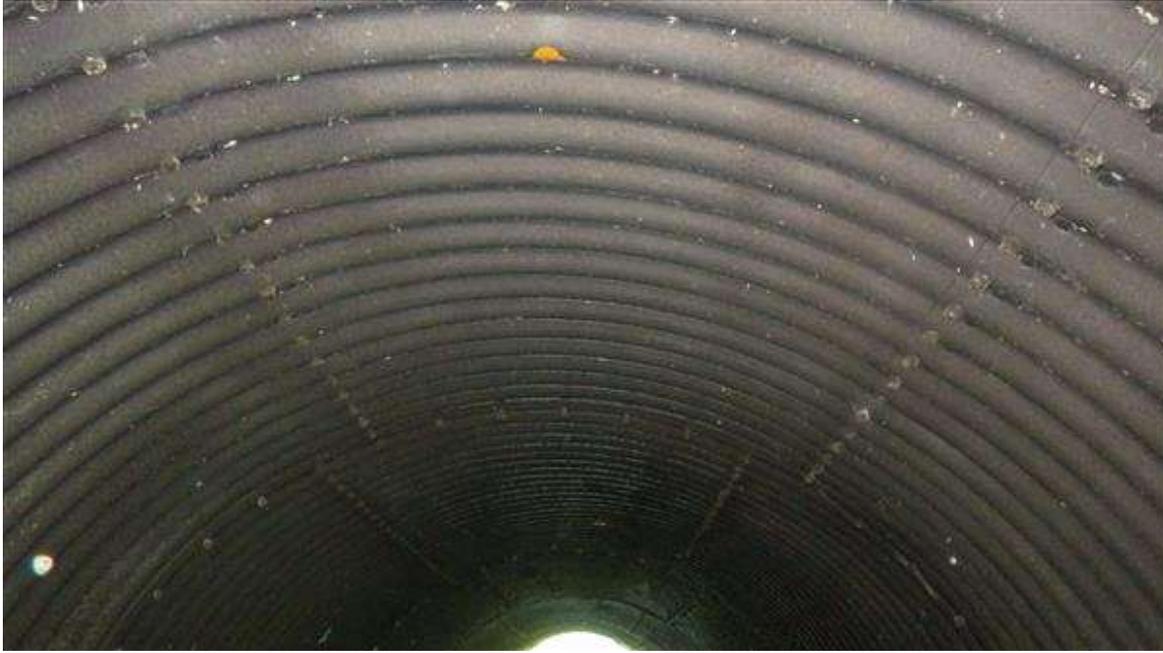
Photo Number: 17

General view of the top plates {intrados}.

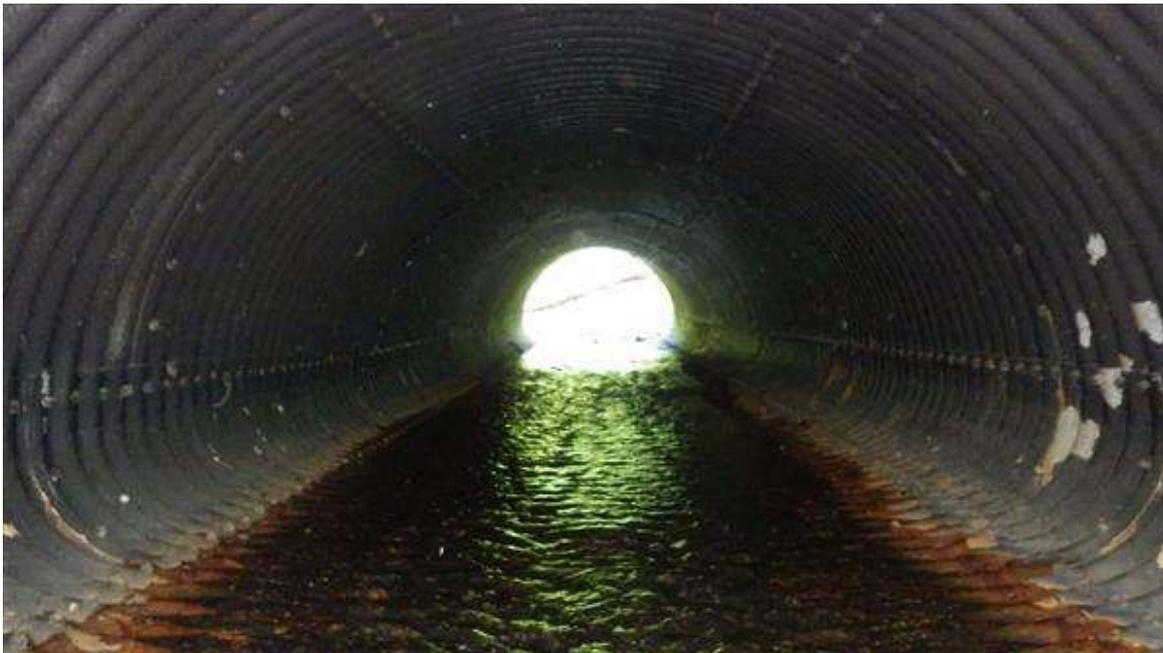
Photo Number: 18

General view through cell # 2.

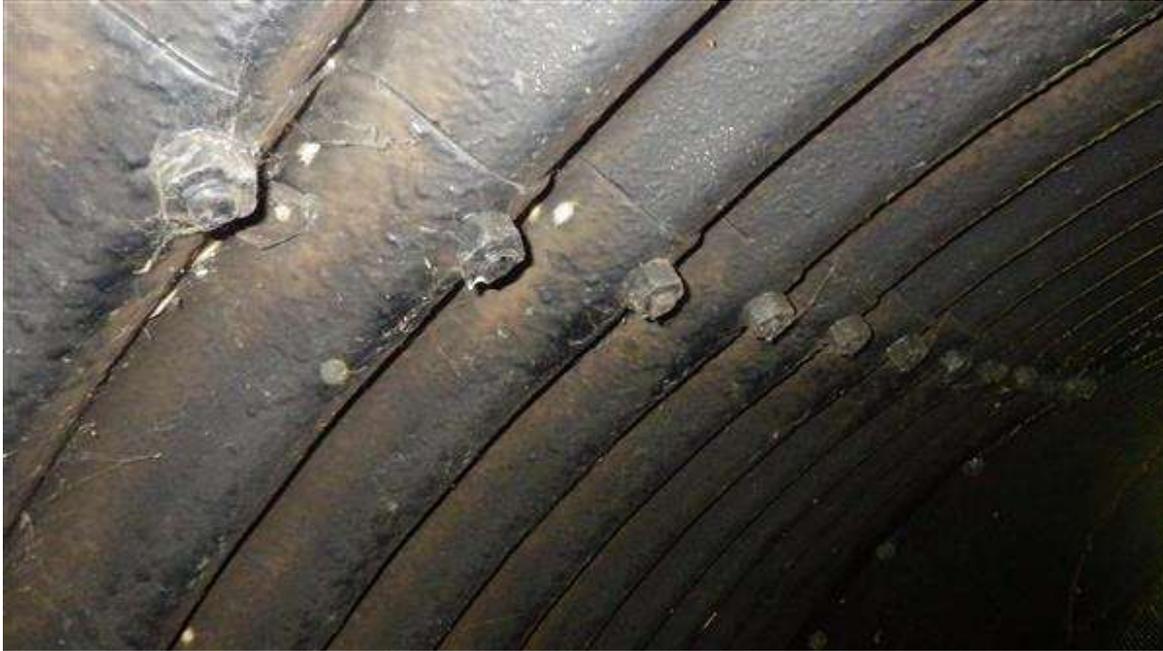
Photo Number: 19

Typical condition of the upper bolt lines in cell # 1.

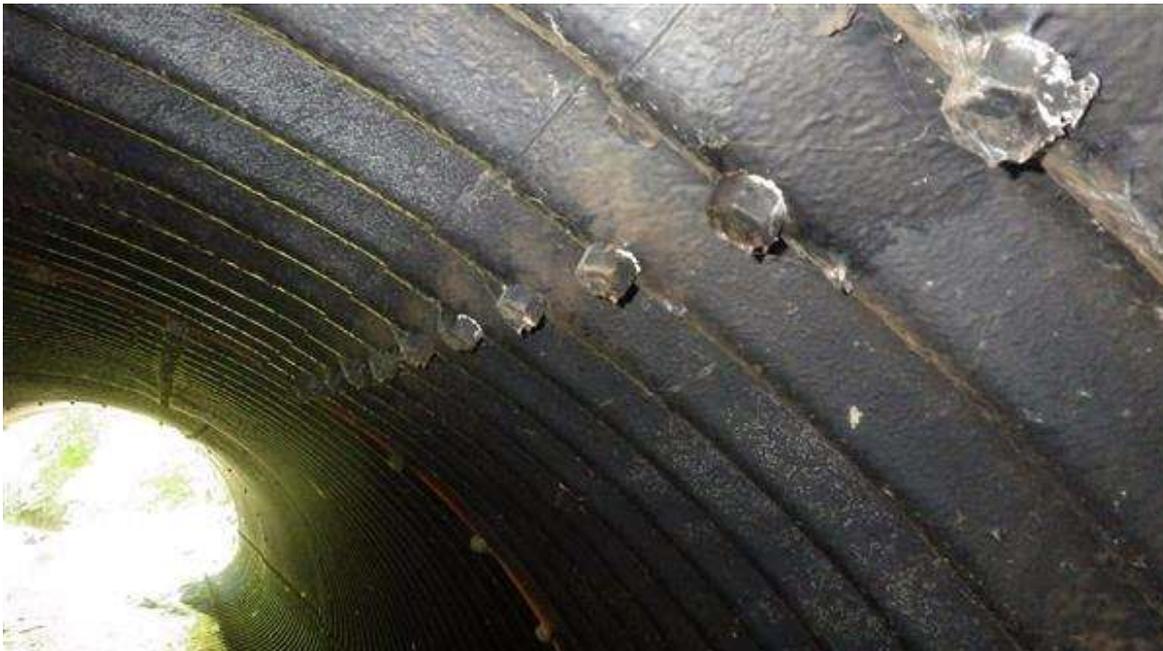
Photo Number: 20

Typical condition of the upper bolt lines in cell # 2.

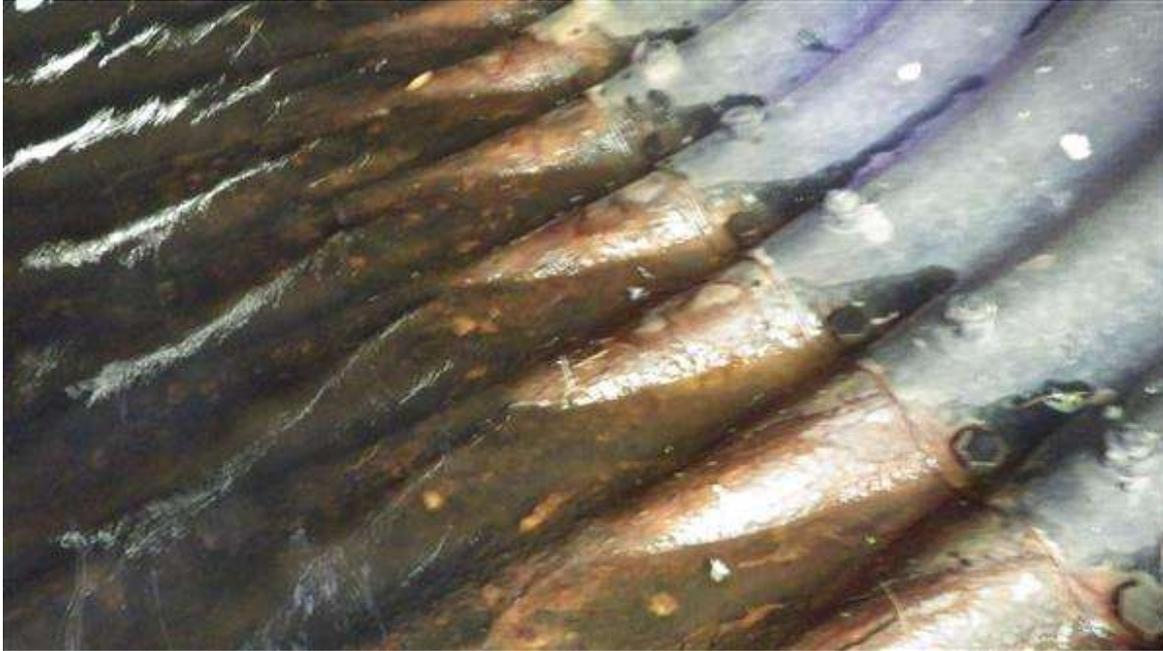
Photo Number: 21

The remainder of the invert plates exhibits heavy rust areas with pronounced thinning.

Heavy rust conditions on the invert plates, typical throughout both cells.

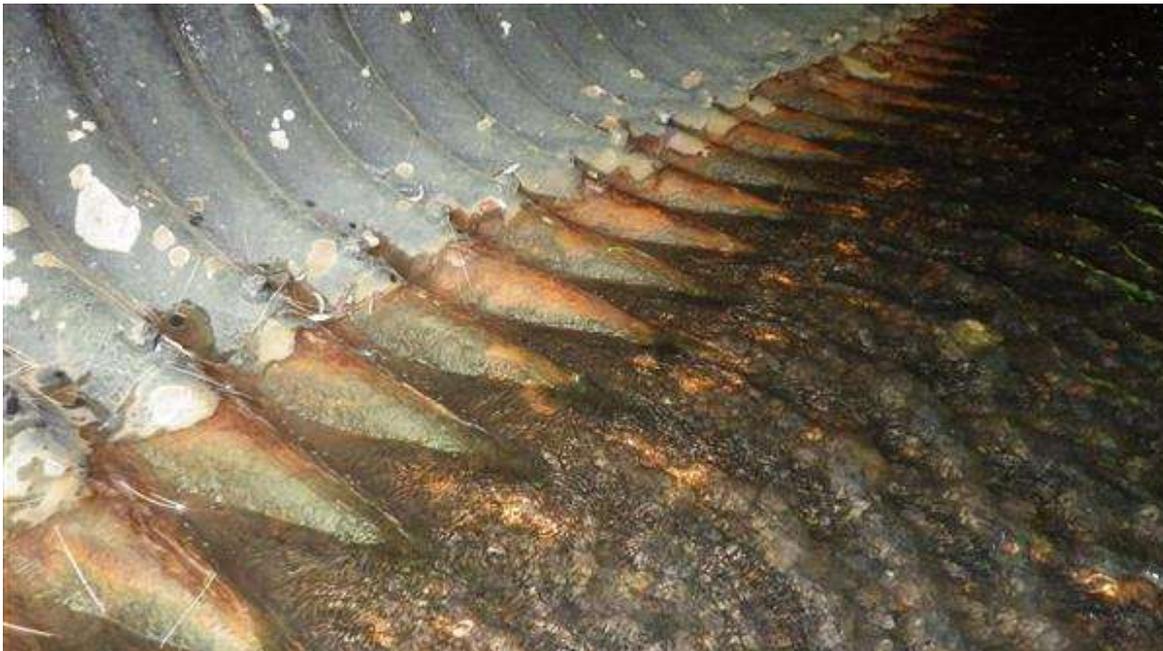
Photo Number: 22

Another view of typical heavy rust conditions throughout.

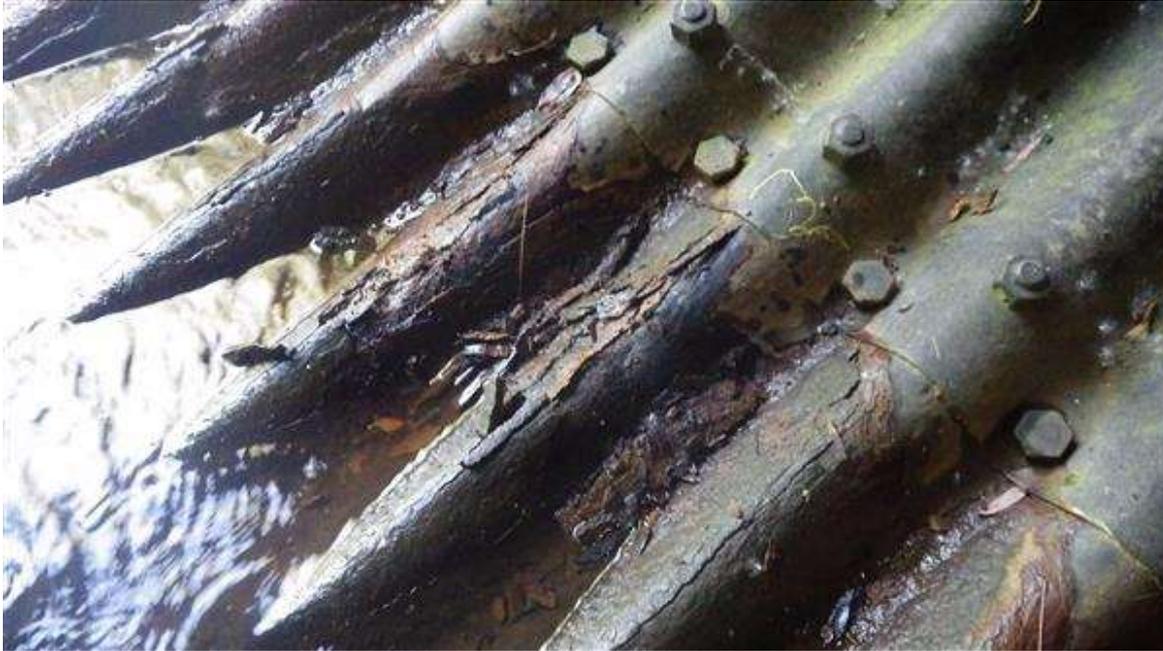
Photo Number: 25

Heavy rust conditions with thin dentable and easily perforated steel at the interface of the lower corner plates and the invert plates, typical throughout both cells.

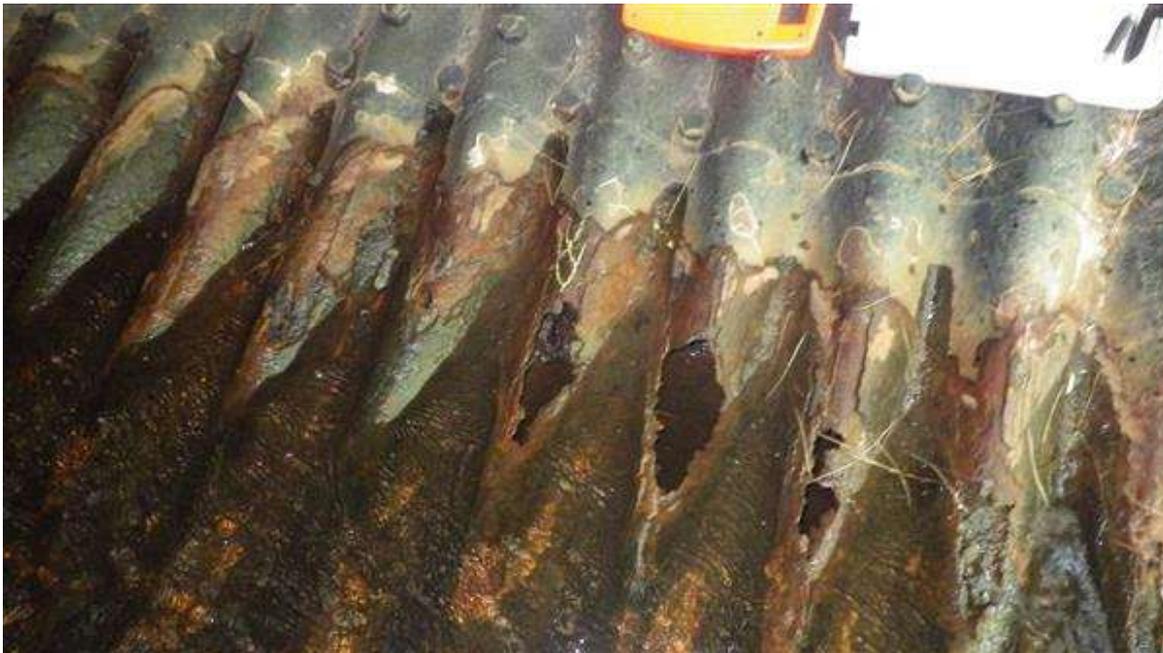
Photo Number: 26

Large perforation holes at the outlet end of A-2.

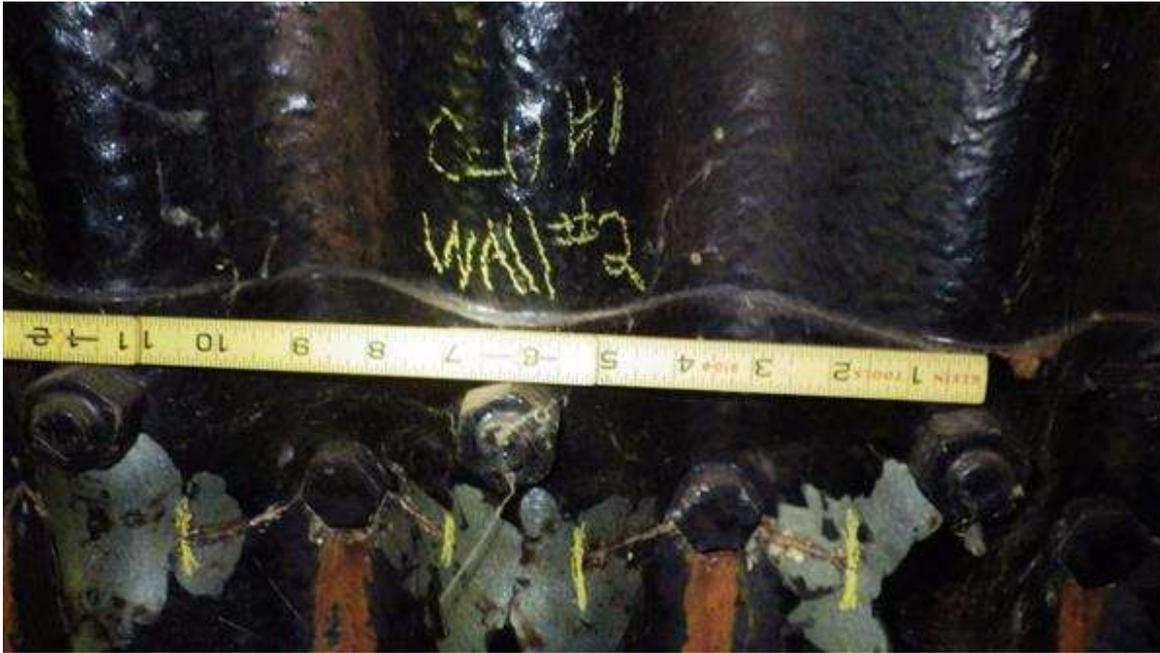
Photo Number: 27

bolt line. Cracks are up to 4" long {Approximately 2 inches Long on Each Side of the Bolt} x 1/8" open. Note: 4" of steel remaining till cracks connect. Field note "Location "C".

Horizontal cracking in the inner lower bolt line in cell # 1.

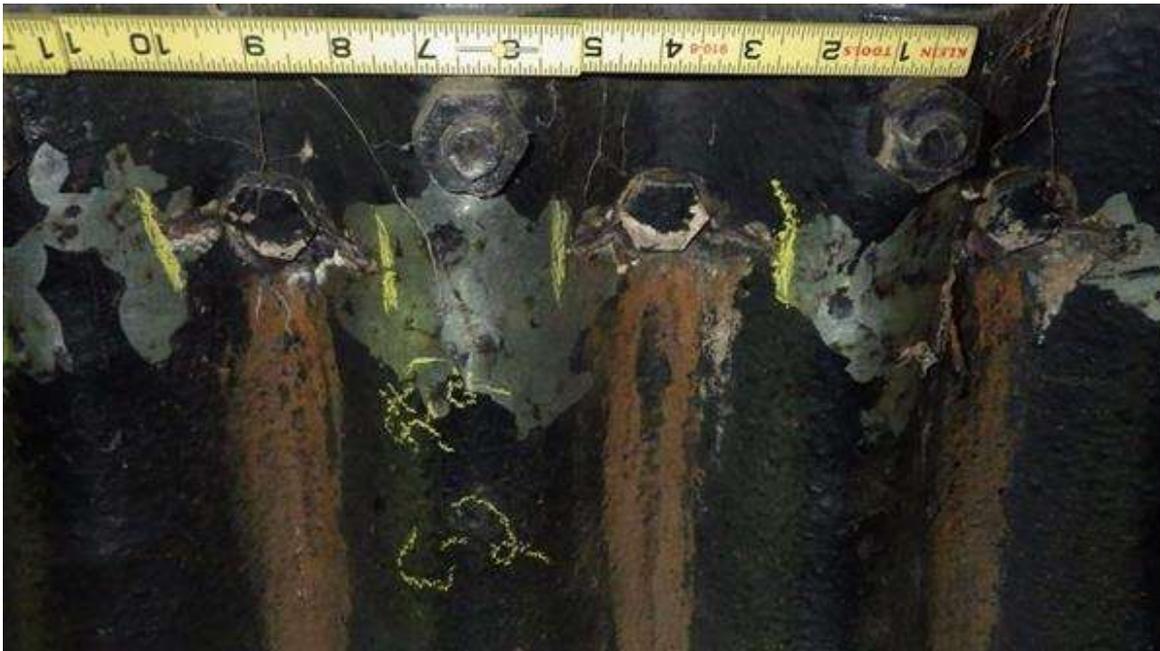
Photo Number: 28

Horizontal cracking in the inner lower bolt line in cell # 2.

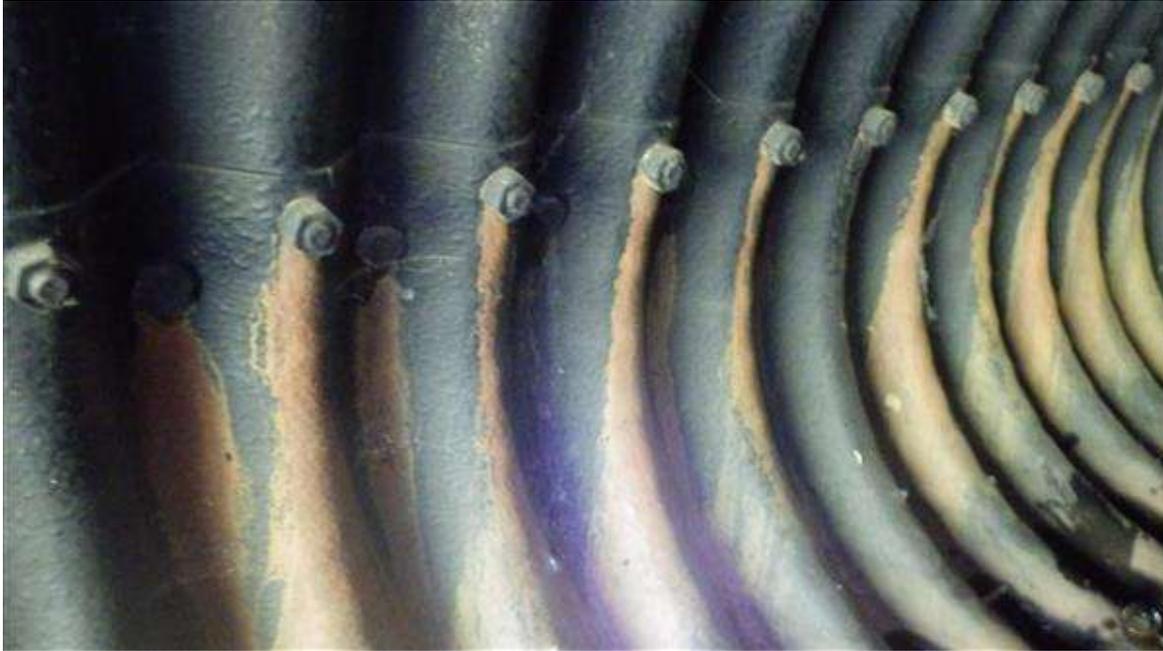
Photo Number: 29

Active and past leakage noted in the lower bolt lines, typical in both cells.
