# CROMWELL TOWN HALL SENIOR CENTER, 19 COMMUNITY FIELD ROAD & 20 JAMES MARTIN DRIVE FEASIBILITY / SPACE NEEDS STUDY

## Phase 1: Former Public Works Garages Assessment Report

8/11/2021

SILVER / PETRUCELLI + ASSOCIATES

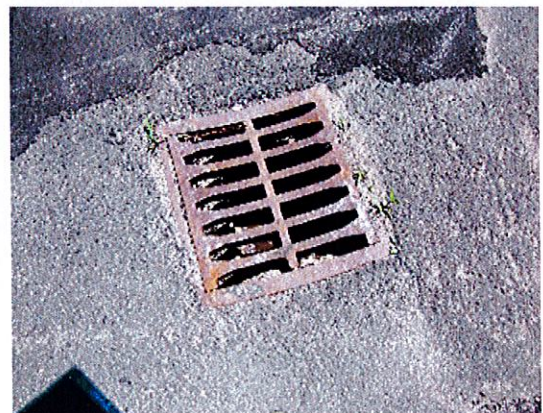
Figure 2

The catch basins in Community Field Road adjacent the site appear to be functional. There is a catch basin frame/grate at a low point adjacent the northeast corner of the site (Figure 2). It appears that there is an existing 30" RCP pipe running directly under the pavement and a hole was cut over the top of the pipe and the grate placed directly over the hole. This is not a preferred solution, and it is assumed this grate was an afterthought to deal with local site ponding. The pipe and the grate/structure should be replaced.

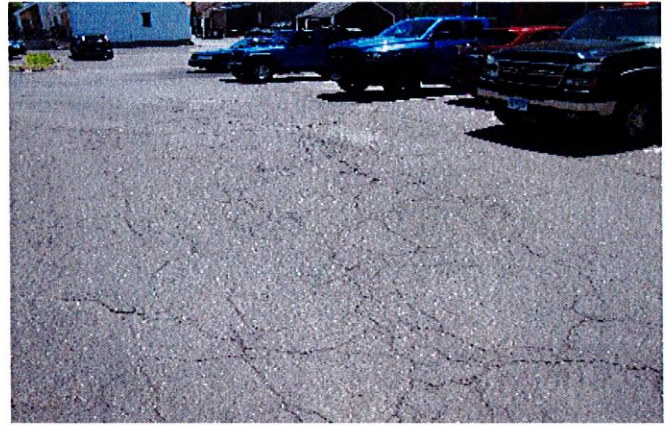
Figure 3

The bituminous pavement (vehicular areas and sidewalks) (Figure 3) is in disrepair and requires replacement. Depending on the nature and depth of the existing base material, as well as the proposed site grading for a future site renovation, the pavement will require mill/overlay, full depth replacement or in-place reclamation. In addition to the dependency on the proposed grading, the type of pavement renovation can be determined by performing several test pits to determine the depth of pavement and base material, and the testing of the base material for grain size analysis.

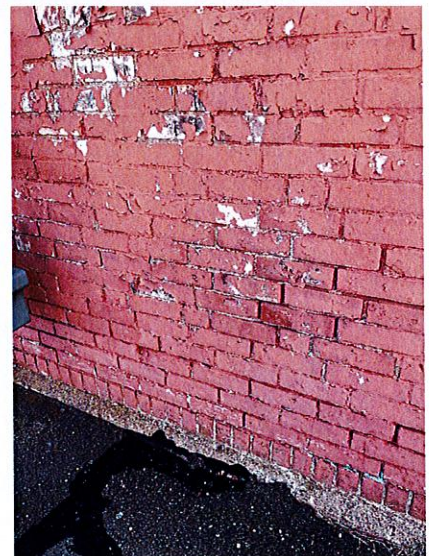
The exterior of the building is in disrepair. A variety of materials are evident with both brick and concrete masonry units (CMU) painted. The existing construction is brick masonry which is evident at the west elevation. It then meets the addition constructed from concrete masonry units (CMU) at the rear portion and all the way around. The energy efficiency of the original construction is very low, and typical in the 1950s and 1960s ("pre energy crisis"), and not one that is easily corrected. Both the brick and CMU have areas of stepped cracking at mortar joints, spalling bricks with areas in need of repointing or replacement. Overall, the mortar is in fair condition with wall areas of roughly 30% in need of repointing. The exterior is also painted. Most areas, aside from the mural at the north, need repainting as the paint is peeling. The gable ends of the roof and the south portion around the

garage doors are sheathed in vertical wood siding which also needs some replacement, and repainting. Areas low to the ground are deteriorating more than others. Above the garage doors, metal siding covers the remainder of this exterior wall. This portion is in fair condition with a few dents and areas where lights were replaced that need paint.

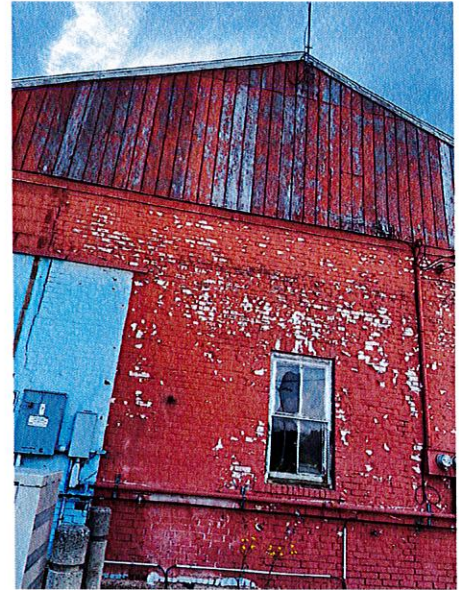
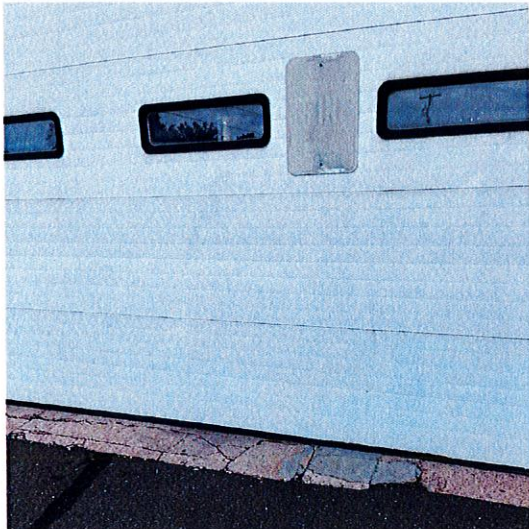
When evaluating the energy efficiency of a building, it is known that nearly 25–40% of all heat energy is lost through windows. The windows are double hung systems in punched openings. There are at least two vintages of window systems. Some are replacement double-glazed vinyl frame windows that are in fair condition. Others are older wood systems. These have peeling paint, and some have broken panes. Caulk is beginning to fail and in need of replacement.

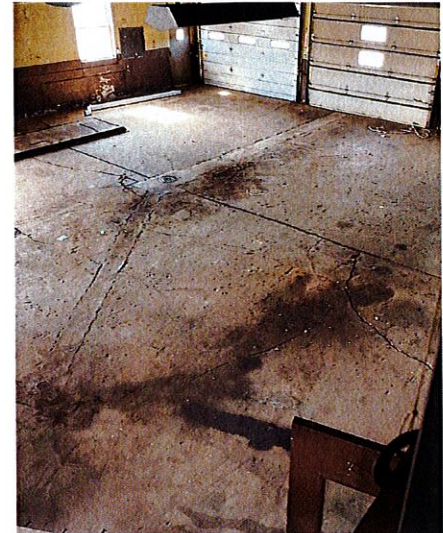
The floors are a variety of materials. The main level consisting largely of the apparatus bays are a concrete slab. Accessory spaces such as the lavatory and storage rooms are also an exposed concrete floor. A recessed pit is in one bay. There is cracking and staining throughout much of the areas. Slabs will need some repairs to the cracks. A finished flooring will not adhere well to this oil-soaked slab so if this building is converted to another use that will require finished level flooring it is advised to install a new floor supported on sleepers over the existing slab.

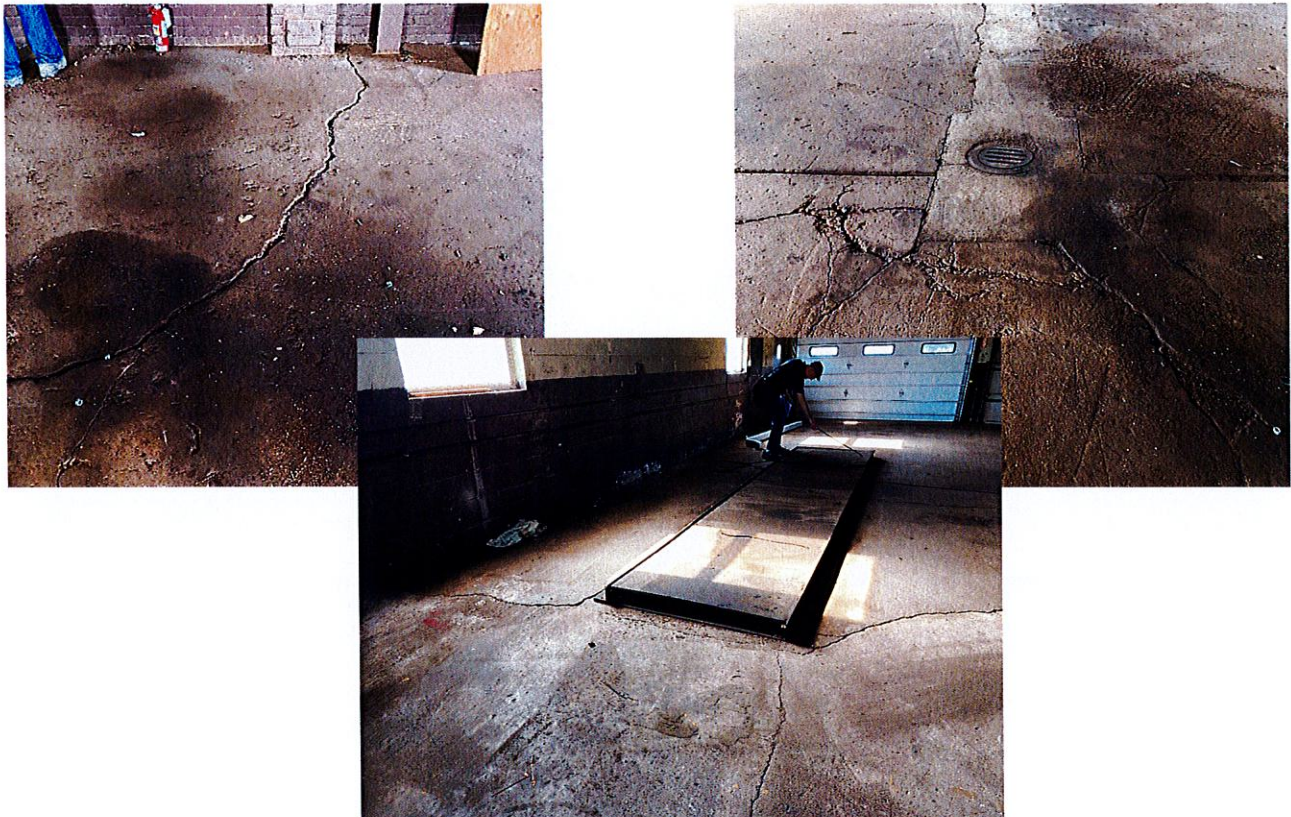
The foundation system for this structure is unknown. The floor is an exposed, cast-in-place concrete slab. A large, approximately 6-foot-deep pit with a removable cover, is located in the eastern side of the garage bays. Significant cracking of the slab was observed throughout and requires repair. Note: The slab appears to be oil soaked, therefore bonding of any proposed finishes could be an issue.

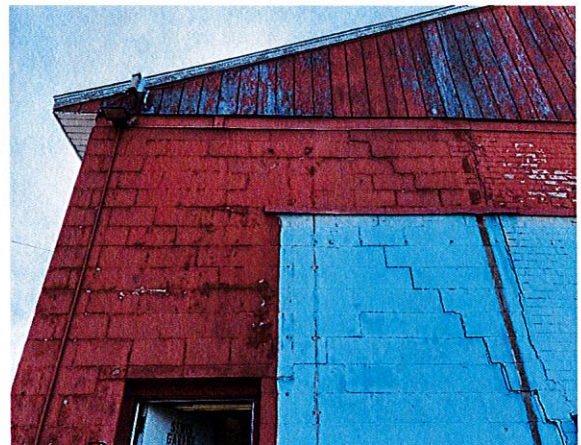
The exterior walls of the original building are multiwythe brick masonry, and the exterior walls of the addition are concrete masonry units (CMU) with three courses of brick above the CMU on the east elevation. Cracking of the CMU was observed in numerous locations at the perimeter of the addition. The masonry (brick and CMU) should be re-pointed throughout the structure. The jambs of the overhead door openings should have the trim removed and the masonry inspected. Water infiltration is evident throughout the structure. The envelope should be addressed by the architect or a building envelope consultant.

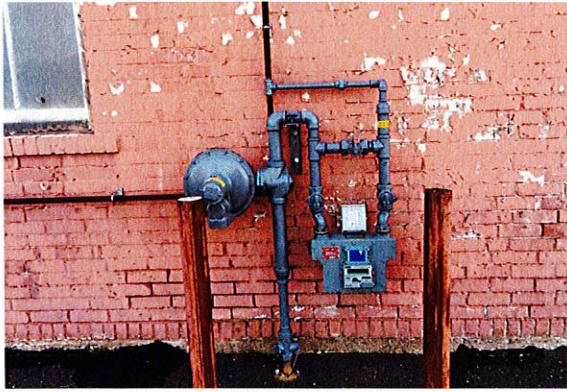
Gas meter

The gas service is routed from a gas main in Community Field Road to the exterior east wall of the building, where the service pressure regulator, gas meter, and additional building pressure regulators are located. Gas is distributed to the emergency generator and the furnace, using black steel pipe. Exterior gas piping surface corrosion is present.

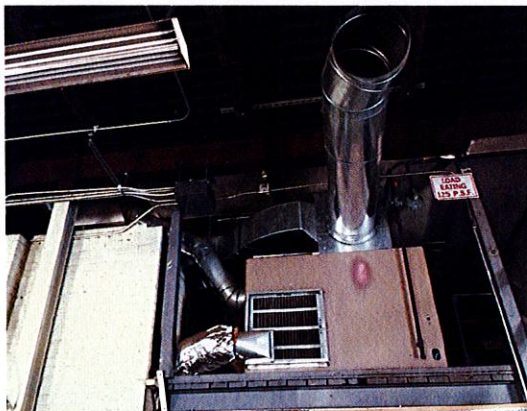
Gas Furnace in mezzanine

The system is beyond its useful service life and was designed for industrial use. If the building is converted to other use such as Business or Assembly, the HVAC system will need to be replaced with systems applicable for its intended use in providing thermal comfort and acceptable indoor air quality.

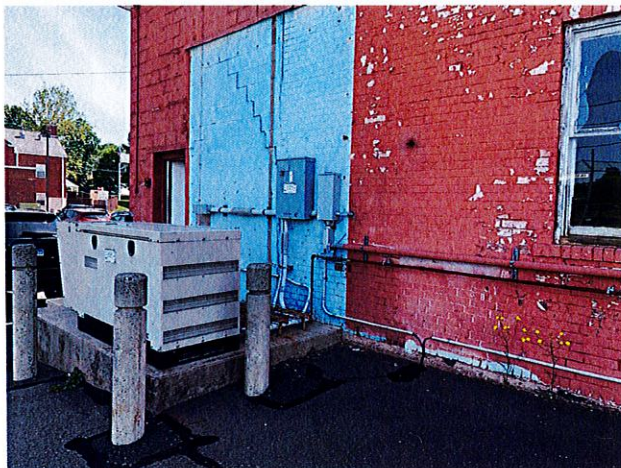
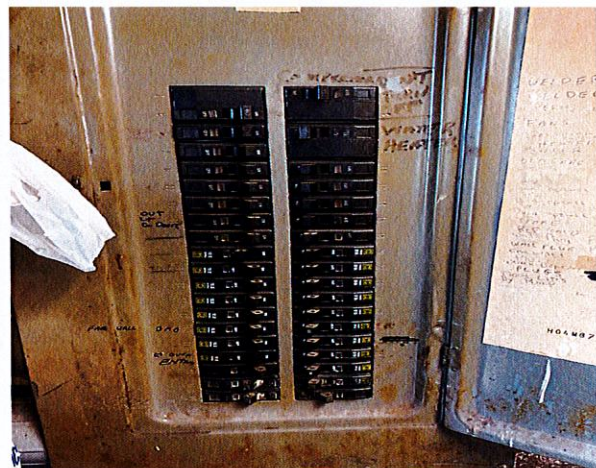
Power distribution is based on a 200 amp enclosed circuit breaker that is interconnected with the generator manual transfer switch. The manual transfer switch is interconnected with the generator and main electrical panel that feeds the entire building. The main enclosed circuit breaker and the manual transfer switch are located on the building exterior wall, and the main electrical panel is in the interior of the building. Based on observation, the main electrical panel serving the entire building is near the end of its useful life. The enclosed main circuit breaker, generator, and manual transfer switch appear to be added later as part of the generator installation. The service main enclosed circuit breaker and infrastructure is in fair condition. However, the main electrical panel is in poor condition, and given the age of the panel, replacement parts may be difficult to obtain. Therefore, it is not viable for reuse as part of any future project. The standby generator, associated manual transfer switch, and infrastructure appear to be in fair condition. It is important to note that the evaluation was based on observation and therefore, electrical components and wiring within the electrical equipment were not inspected or tested for performance. Since some electrical infrastructure is original from when the building was constructed, it is highly recommended that a certified professional performs additional investigations to determine the integrity of critical components inside the electrical equipment.

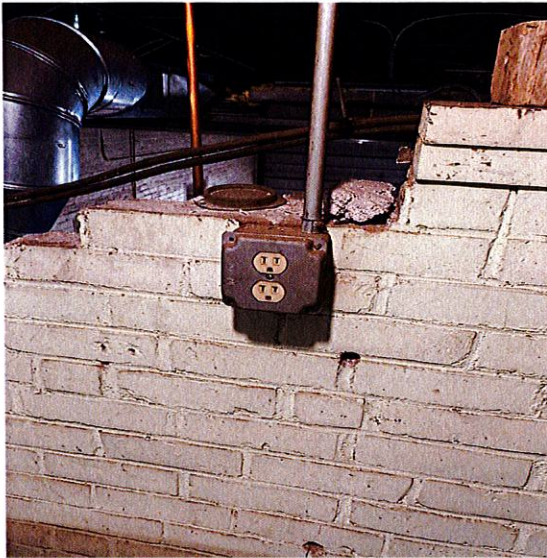
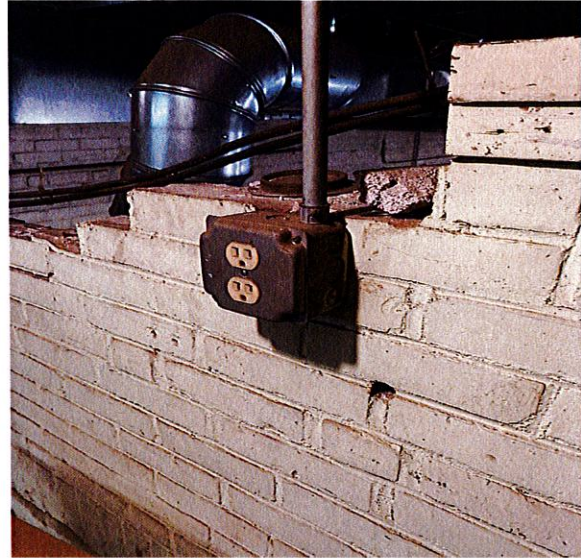
Power receptacles throughout the building are surface mounted receptacles mounted at approx. 36" above the finished floor. Receptacles are fed via surface-mounted EMT conduit. Power receptacles seem to be original from when the building was constructed. Most power receptacles, surface backboxes, and associated conduits are in deteriorated condition. Since power receptacles are in deteriorated condition, performance and effectiveness can be affected and create a potentially hazardous environment. No ground fault interrupter power

receptacles were found. Power receptacles will need to be tested and mounting height rearranged if use in a future project is desired.

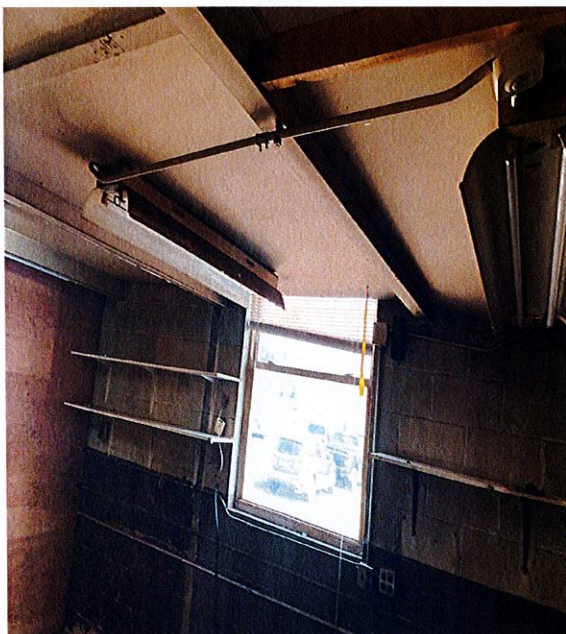
The interior lighting throughout the building consists of a combination of 1' x 4' pendant, surface, and wall-mounted industrial light fixtures with fluorescent lamps. Fixtures are obsolete, outdated, and in deteriorated condition. Illumination levels were not measured, and fixtures were not tested for performance. The typical light fixture lifespan is 15 to 20 years and replacement of these fixtures should be anticipated for any future project along with associated control/light switches. LED fixtures are recommended to be used in future projects. Exterior light fixtures are not original, and they were replaced with LED fixtures. They are controlled via photocell and fixtures appear to be in good condition, however, they need to be cleaned.

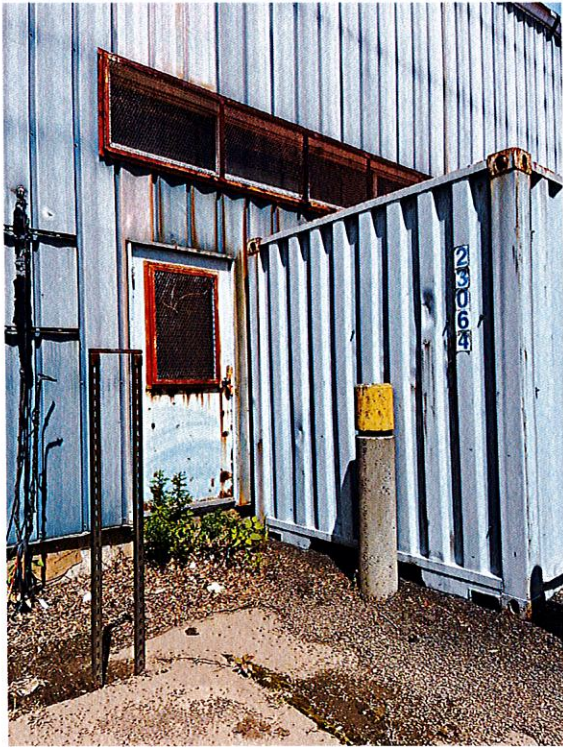
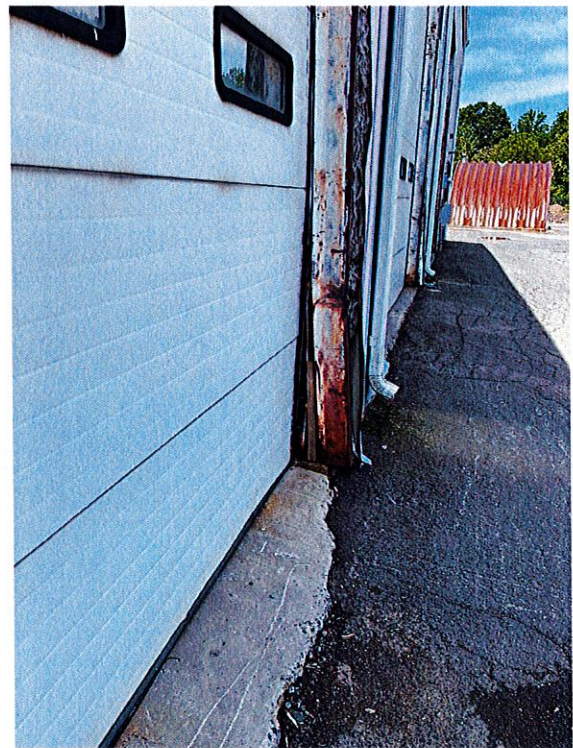
The exterior doors are metal and like the other exterior materials they too are nearing the end of their useful life. They are showing signs of rust and deterioration. The door hardware is not compliant. The caulking needs to be replaced. These doors should be replaced. The garage doors were not tested for their operability but appear to be in fair condition. The jambs of the doors are in disrepair. They are mangled, bent and rusting. Wood is exposed and, in some cases, deteriorating. Insulation is also exposed at some of the jambs. These should be replaced and repaired.

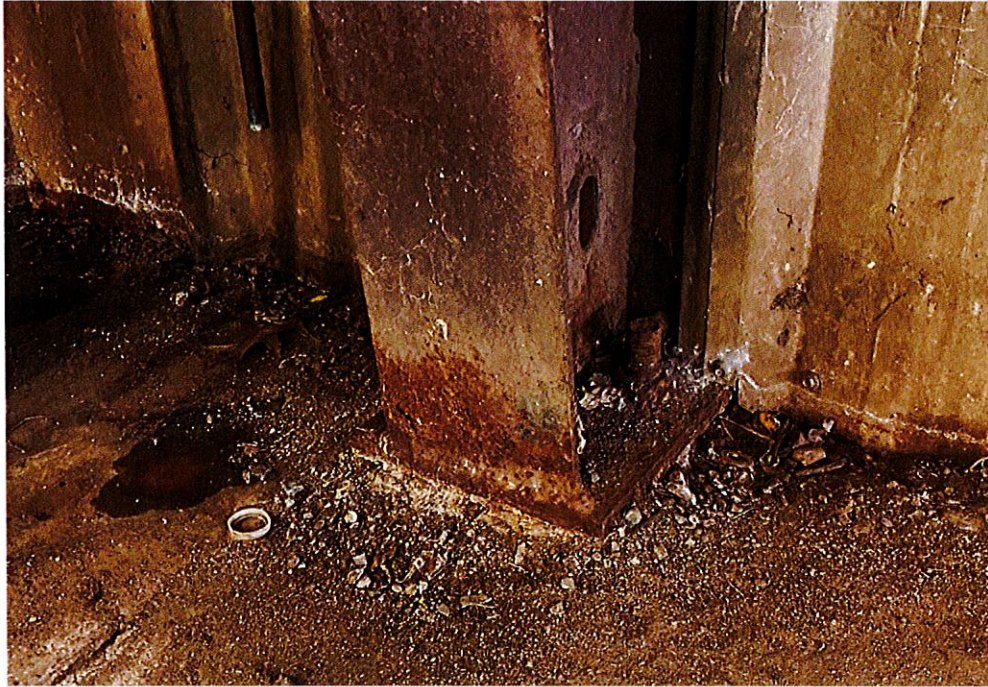
Corrosion of the steel was observed at the base of the rigid building frames. The steel should be cleaned to bare metal and coated with an approved product to prevent further corrosion and potential loss of steel section. Left unaddressed, further corrosion of these frames could be detrimental to the structure.

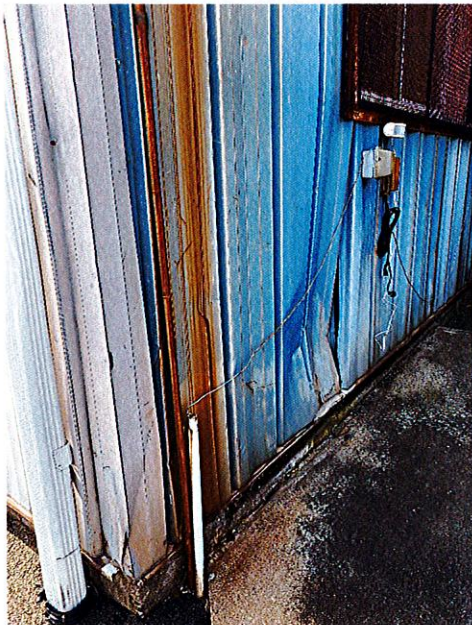
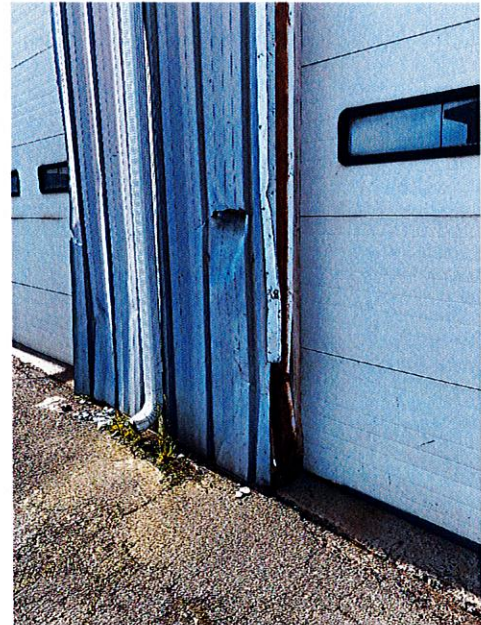
There is a small amount of cast-in-place concrete foundation wall exposed at the exterior walls. The concrete has been parged on the exterior face, which is failing in some areas, however, this does not present a structural concern. The exterior walls above the concrete foundation, consist of pre-engineered metal building components. The exterior metal panels have been damaged due to vehicle impact in numerous areas. The damage to the wall panels and siding allows for water infiltration and pest infestation, however, they do not present a structural concern at this time.

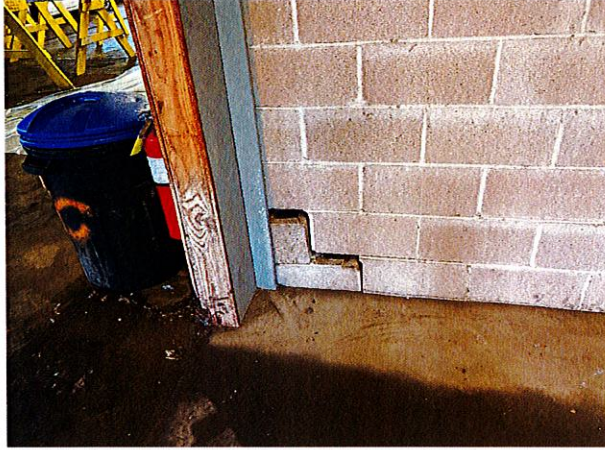
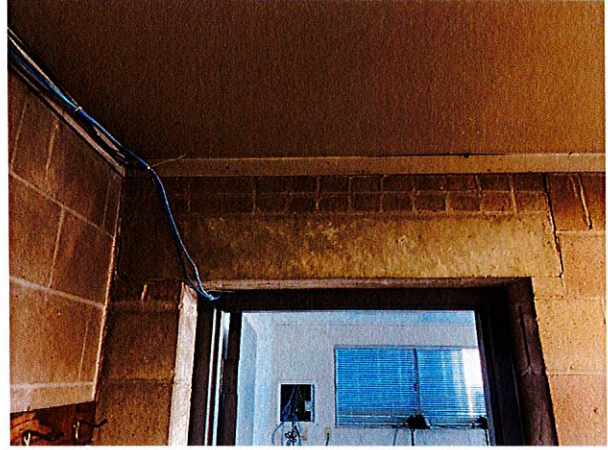
The interior walls of the office and bathroom at the ground floor level are load bearing CMU partitions, supporting the mezzanine framing above. The interior walls above the mezzanine level are wood studs. Some cracking and damage of the CMU was observed.

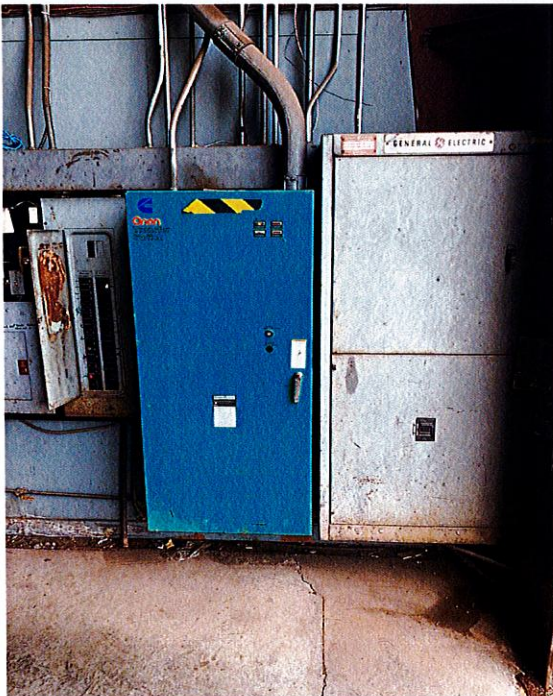
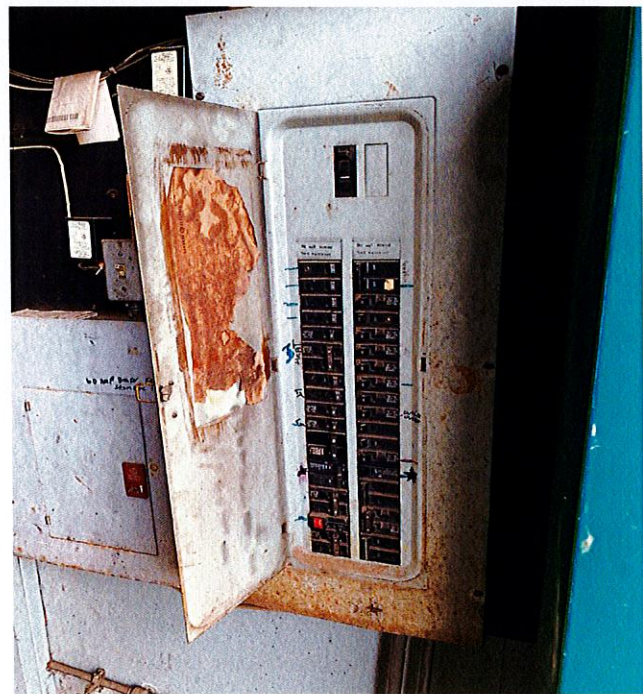
The building electrical service is 400 amp. Although the main switch cabinet is labeled as 120/208V-3 Phase, based on collected information, the service seems to be rated for 120/240V-1Phase. The building service entrance is underground via a utility pole-mounted transformer located near the building. This electrical service also feeds an electrical distribution panel located in the Mechanics Building. In addition to the utility service, the building has what appears to be a diesel standby generator manufactured by Cummins Onan. The generator was not accessible; therefore, the KW rating could not be verified. However, the information on the automatic transfer switch indicates that the generator is rated for 400 amp, 120/240V-1Phase. The generator appears to be backing up the entire electrical service. Power distribution is based on a 400-amp switch cabinet interconnected with a 400A automatic transfer switch which connects to the distribution electrical panel located in Highway Building and in Mechanics Building. There was no label indicating the panel's voltage and amperage rating. Based on observation, the main electrical panel serving the entire building seems to be original from when the building was constructed in 1982. The main switch cabinet and main electrical panel are in poor condition, and given the age of the panel, replacement parts may be difficult to obtain. Therefore, it is not viable for reuse as part of any future project. The standby generator, associated automatic transfer switch, and infrastructure appear to be in fair condition. It is important to note that the evaluation was based on observation and therefore, electrical components and wiring within the electrical equipment were not inspected or tested for performance. Since electrical infrastructure is original from when the building was constructed, it is highly recommended that a certified professional performs additional investigations to determine the integrity of critical components inside the electrical equipment.

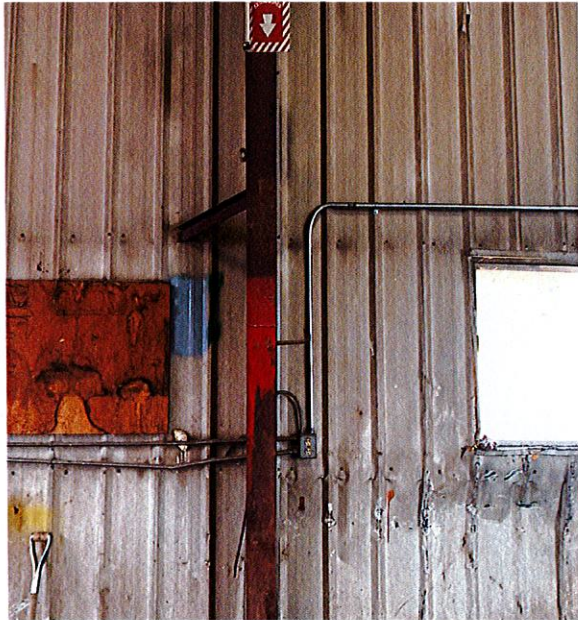
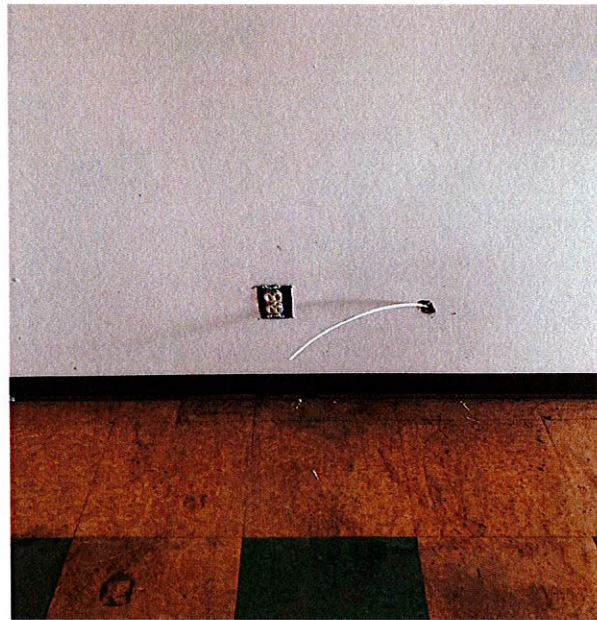
Power receptacles throughout the building are a combination of recessed and surface mounted receptacles mounted at approx. 36" above the finished floor in the garage area and 18" above the finished floor in the office area. Some power receptacles seem to be original from when the building was constructed in the garage area, and some seem to be more recently replaced. Most power receptacles, surface backboxes, and associated exposed conduits in the garage area are in fair condition. Power receptacles in the Office area seem to be in fair condition also; however, multiple receptacles lacked a cover plate. Power receptacles will need to be tested and mounting height rearranged if use in a future project is desired.

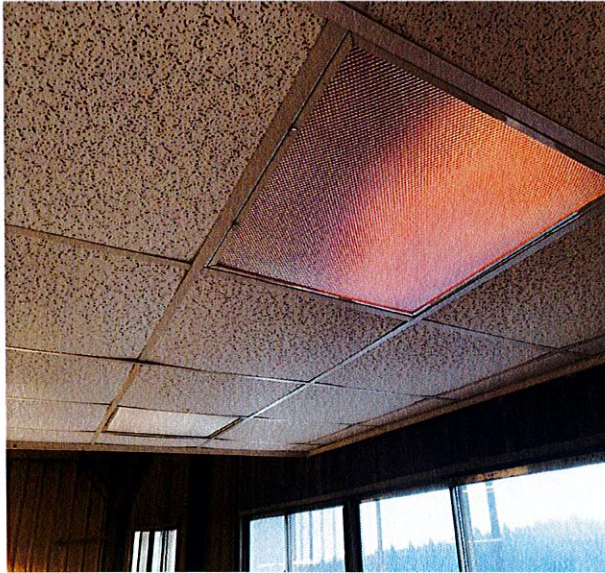
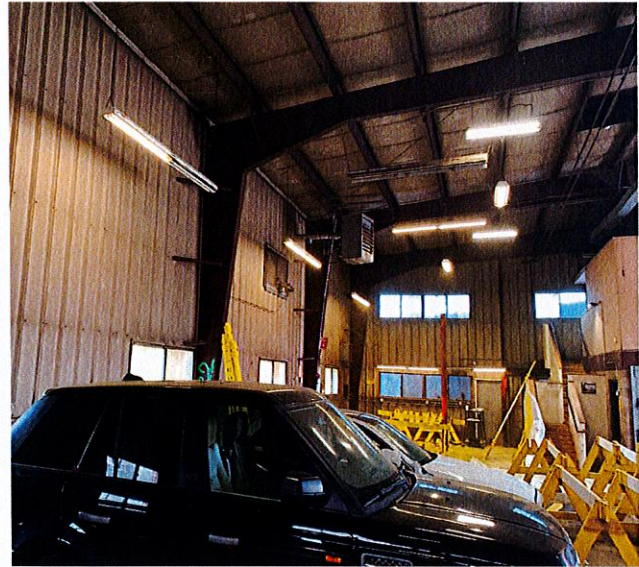
The interior lighting throughout the building consists of a combination of 1' x 4' pendant, wall-mounted industrial light fixtures with fluorescent lamps in the garage area and recessed 2'x2' with fluorescent lamps in the office area. Light fixtures in the garage seem to be original from when the building was constructed. Fixtures in the office area seem to be added later when office space was added. Fixtures in the garage area are obsolete, outdated, and in deteriorated condition. Fixtures in the office area are in fair condition, however, there were multiple inoperative fixtures. Illumination levels were not measured, and fixtures were not tested for performance. The typical light fixture lifespan is 15 to 20 years and replacement of these fixtures should be anticipated for any future project along with associated control/light switches. LED fixtures are recommended to be used in future projects. Exterior light fixtures are not original, and they were replaced with LED fixtures. They are controlled via photocell and fixtures appear to be in fair condition; however, they need to be cleaned.

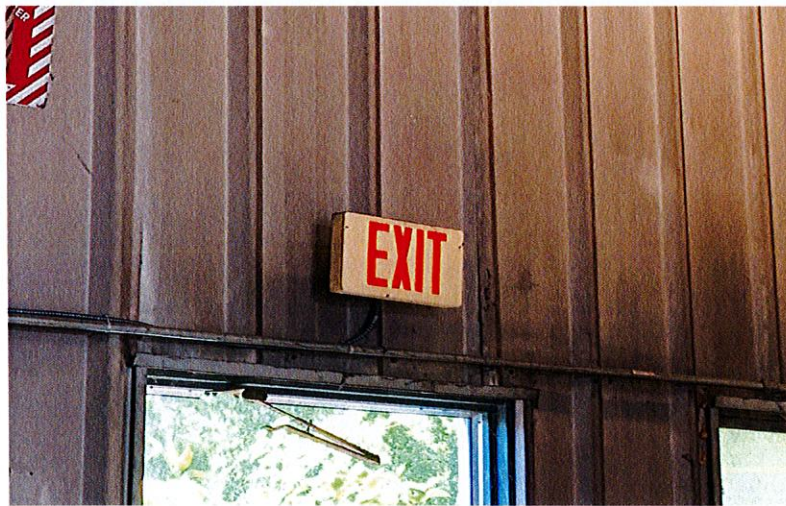
Although there is an existing standby generator backing up the entire building, emergency relays to suit emergency lighting and additional emergency lighting source required by code were not observed throughout the building. Exit signs are illuminated thermoplastic. Exit signs are in fair condition and provided in sufficient numbers for the current building layout.

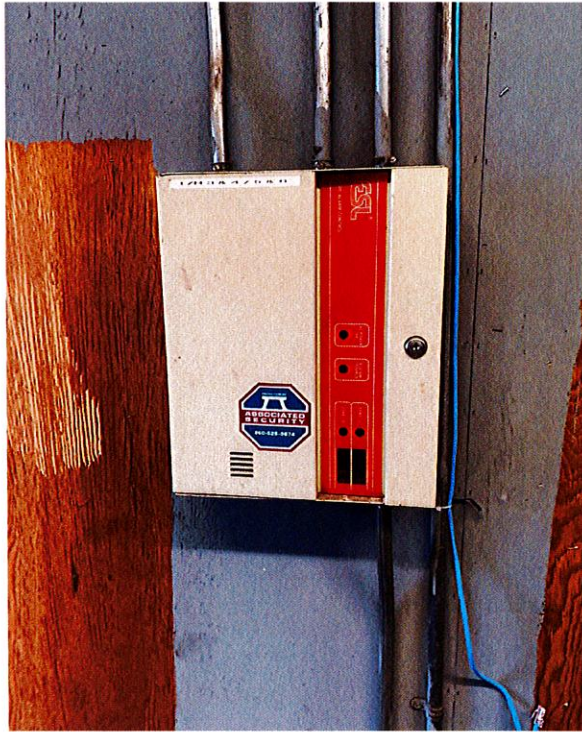
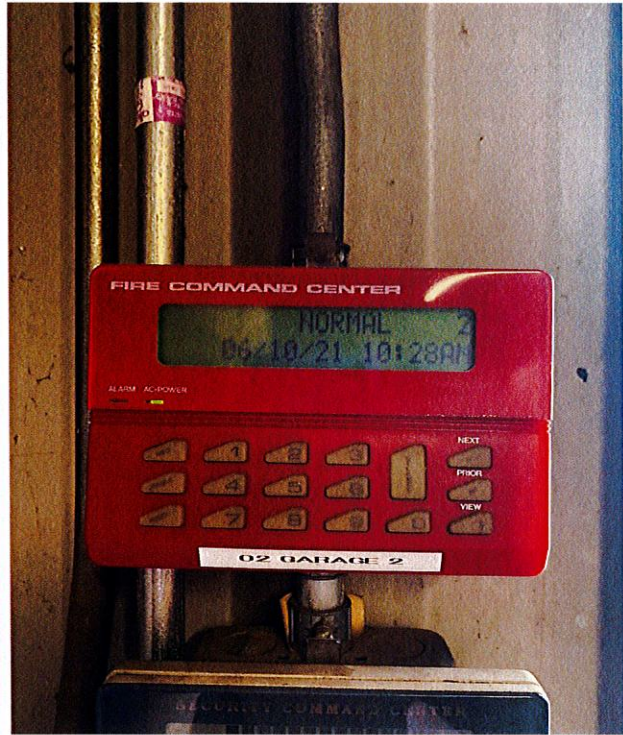
The building fire alarm system is based on a conventional zone fire alarm panel that appears to be inoperative. This system seems to be abandoned. However, there is a remote command center keypad that seems to be fed from the Mechanics Building. There are pull stations at each egress door, heat detectors throughout, and notification devices. Pull stations are in fair condition. Heat detectors are provided in sufficient numbers, and are in fair condition; however, there were many units missing covers. Notification devices were not provided in sufficient numbers, and there are assembly areas lacking notification units. The system should be updated if the building will be used for a future project.

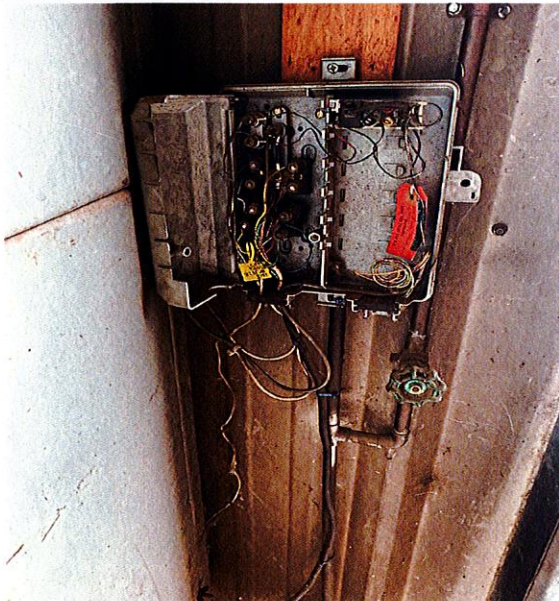
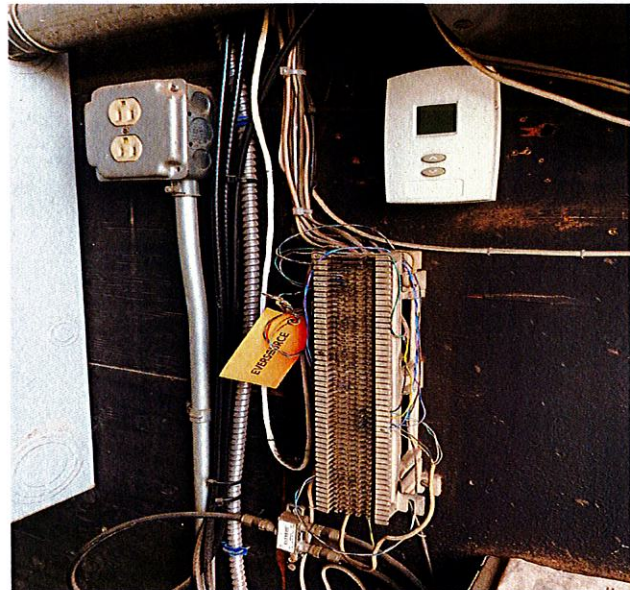
The communication system is an underground connection from a utility pole located near the building and terminated at a utility Dmarc terminal. The Dmarc, terminal, and infrastructure are obsolete and should be replaced with a new system. No data network system was observed.

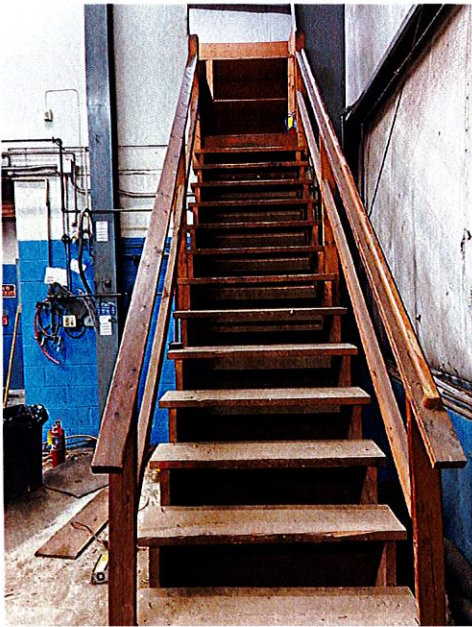
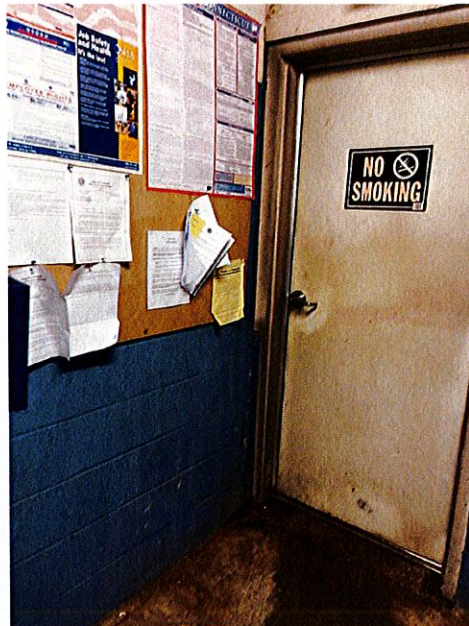
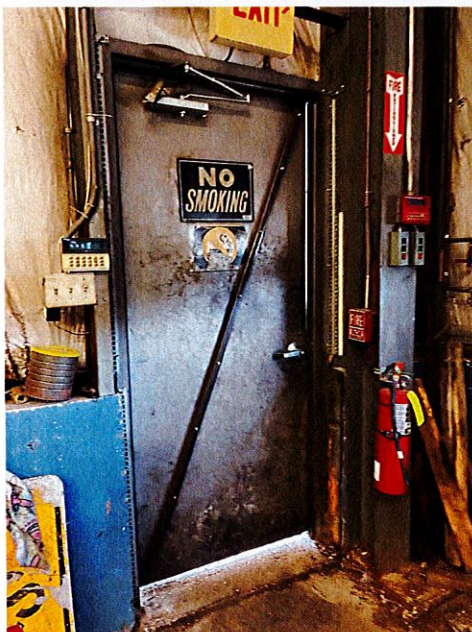
There are numerous code and American Disability Act (ADA) accessibility issues noted at this facility. Like the Highway building, this prefabricated metal structure could be classified as Type 2B construction, but with the construction of the wood joists and subfloor of the mezzanine, combustible materials have now been introduced into the building. It therefore would be classified as Type 5B. Although the walls are above the 42", this space can still be considered as a mezzanine since the occupant count is under 10 people. Therefore, it can meet the requirements of Type 5B. There are other issues involving the mezzanine. The restroom is not accessible due to its location on the mezzanine. It should be located to the lower level or an elevator should be included. The stairs and handrails are not compliant construction and would need to be rebuilt. Other issues are accessibility violations with push pull clearances at doors. Both egress doors have either walls or structure in the required clearances and should be adjusted.
