A FEASIBILITY STUDY FOR
a New Senior Center for the Town of Cromwell

The Town of Cromwell

September 14, 2009

QUISENBERRY ARCARI ARCHITECTS, LLC

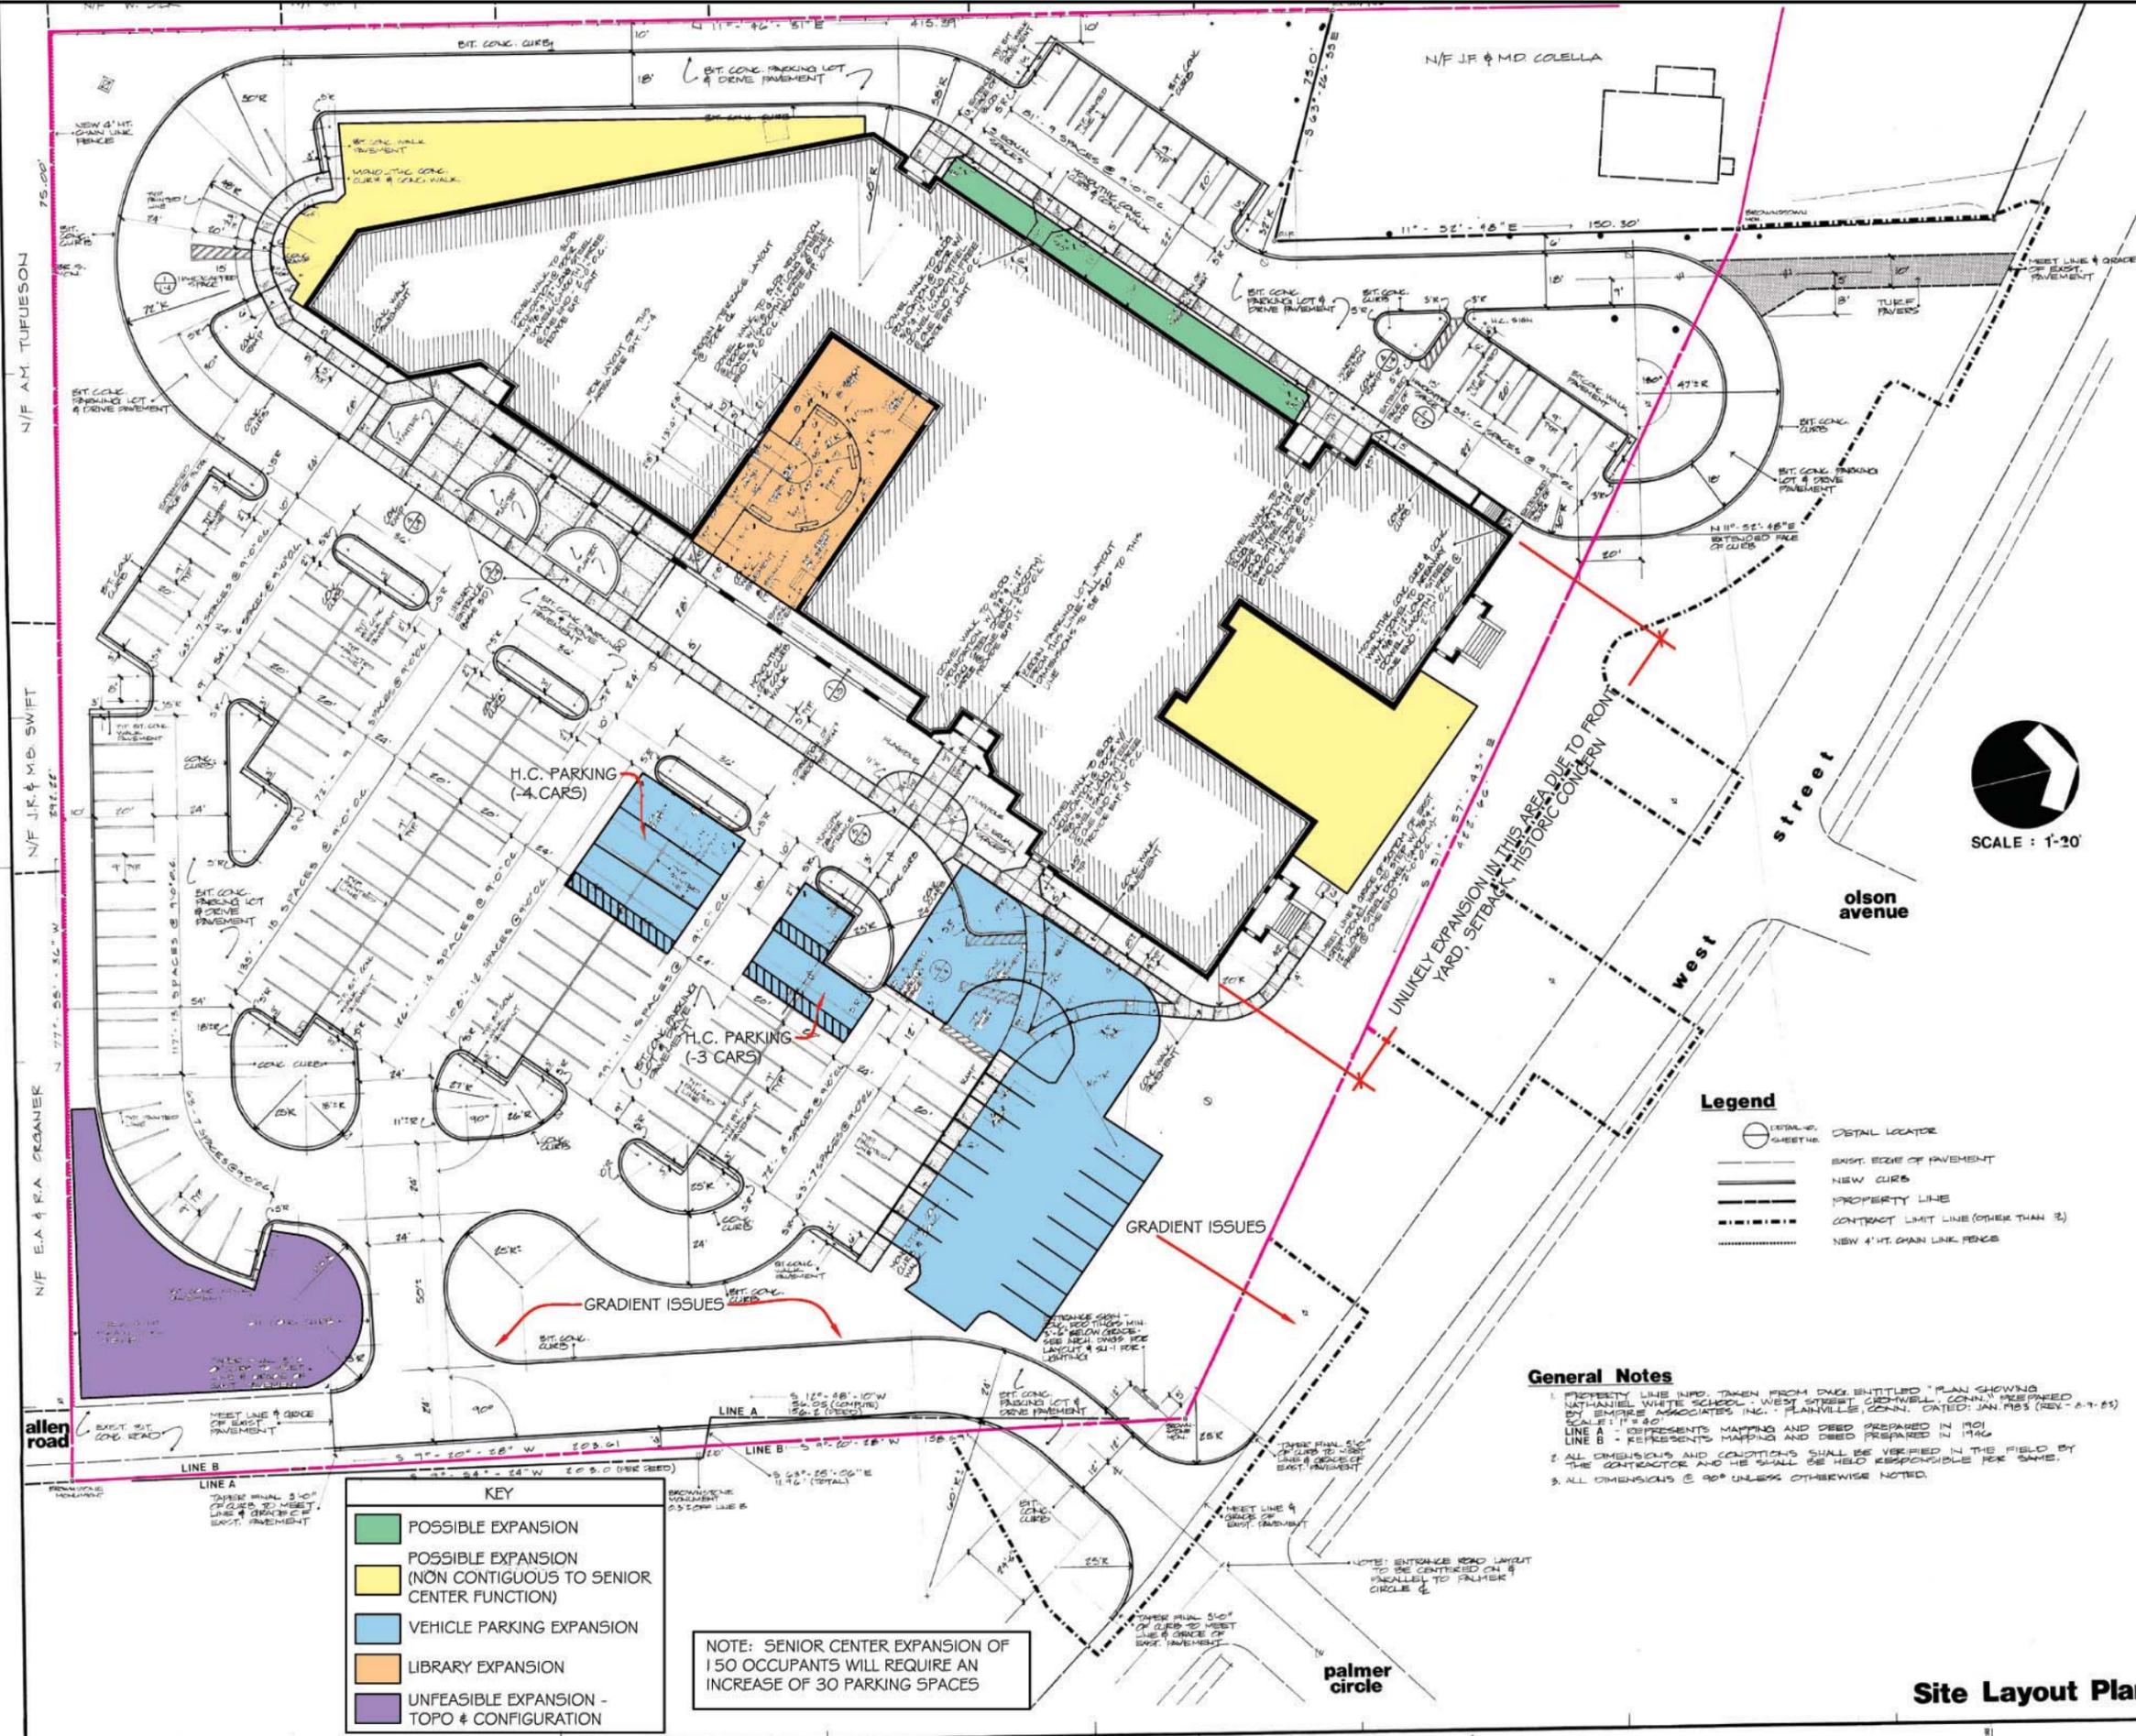
Site Layout Plan

POSSIBLE EXPANSION
	POSSIBLE EXPANSION (NON CONTIGUOUS TO SENIOR CENTER FUNCTION)
	VEHICLE PARKING EXPANSION
	LIBRARY EXPANSION
	UNFEASIBLE EXPANSION - TOPO & CONFIGURATION

NOTE: SENIOR CENTER EXPANSION OF 150 OCCUPANTS WILL REQUIRE AN INCREASE OF 30 PARKING SPACES

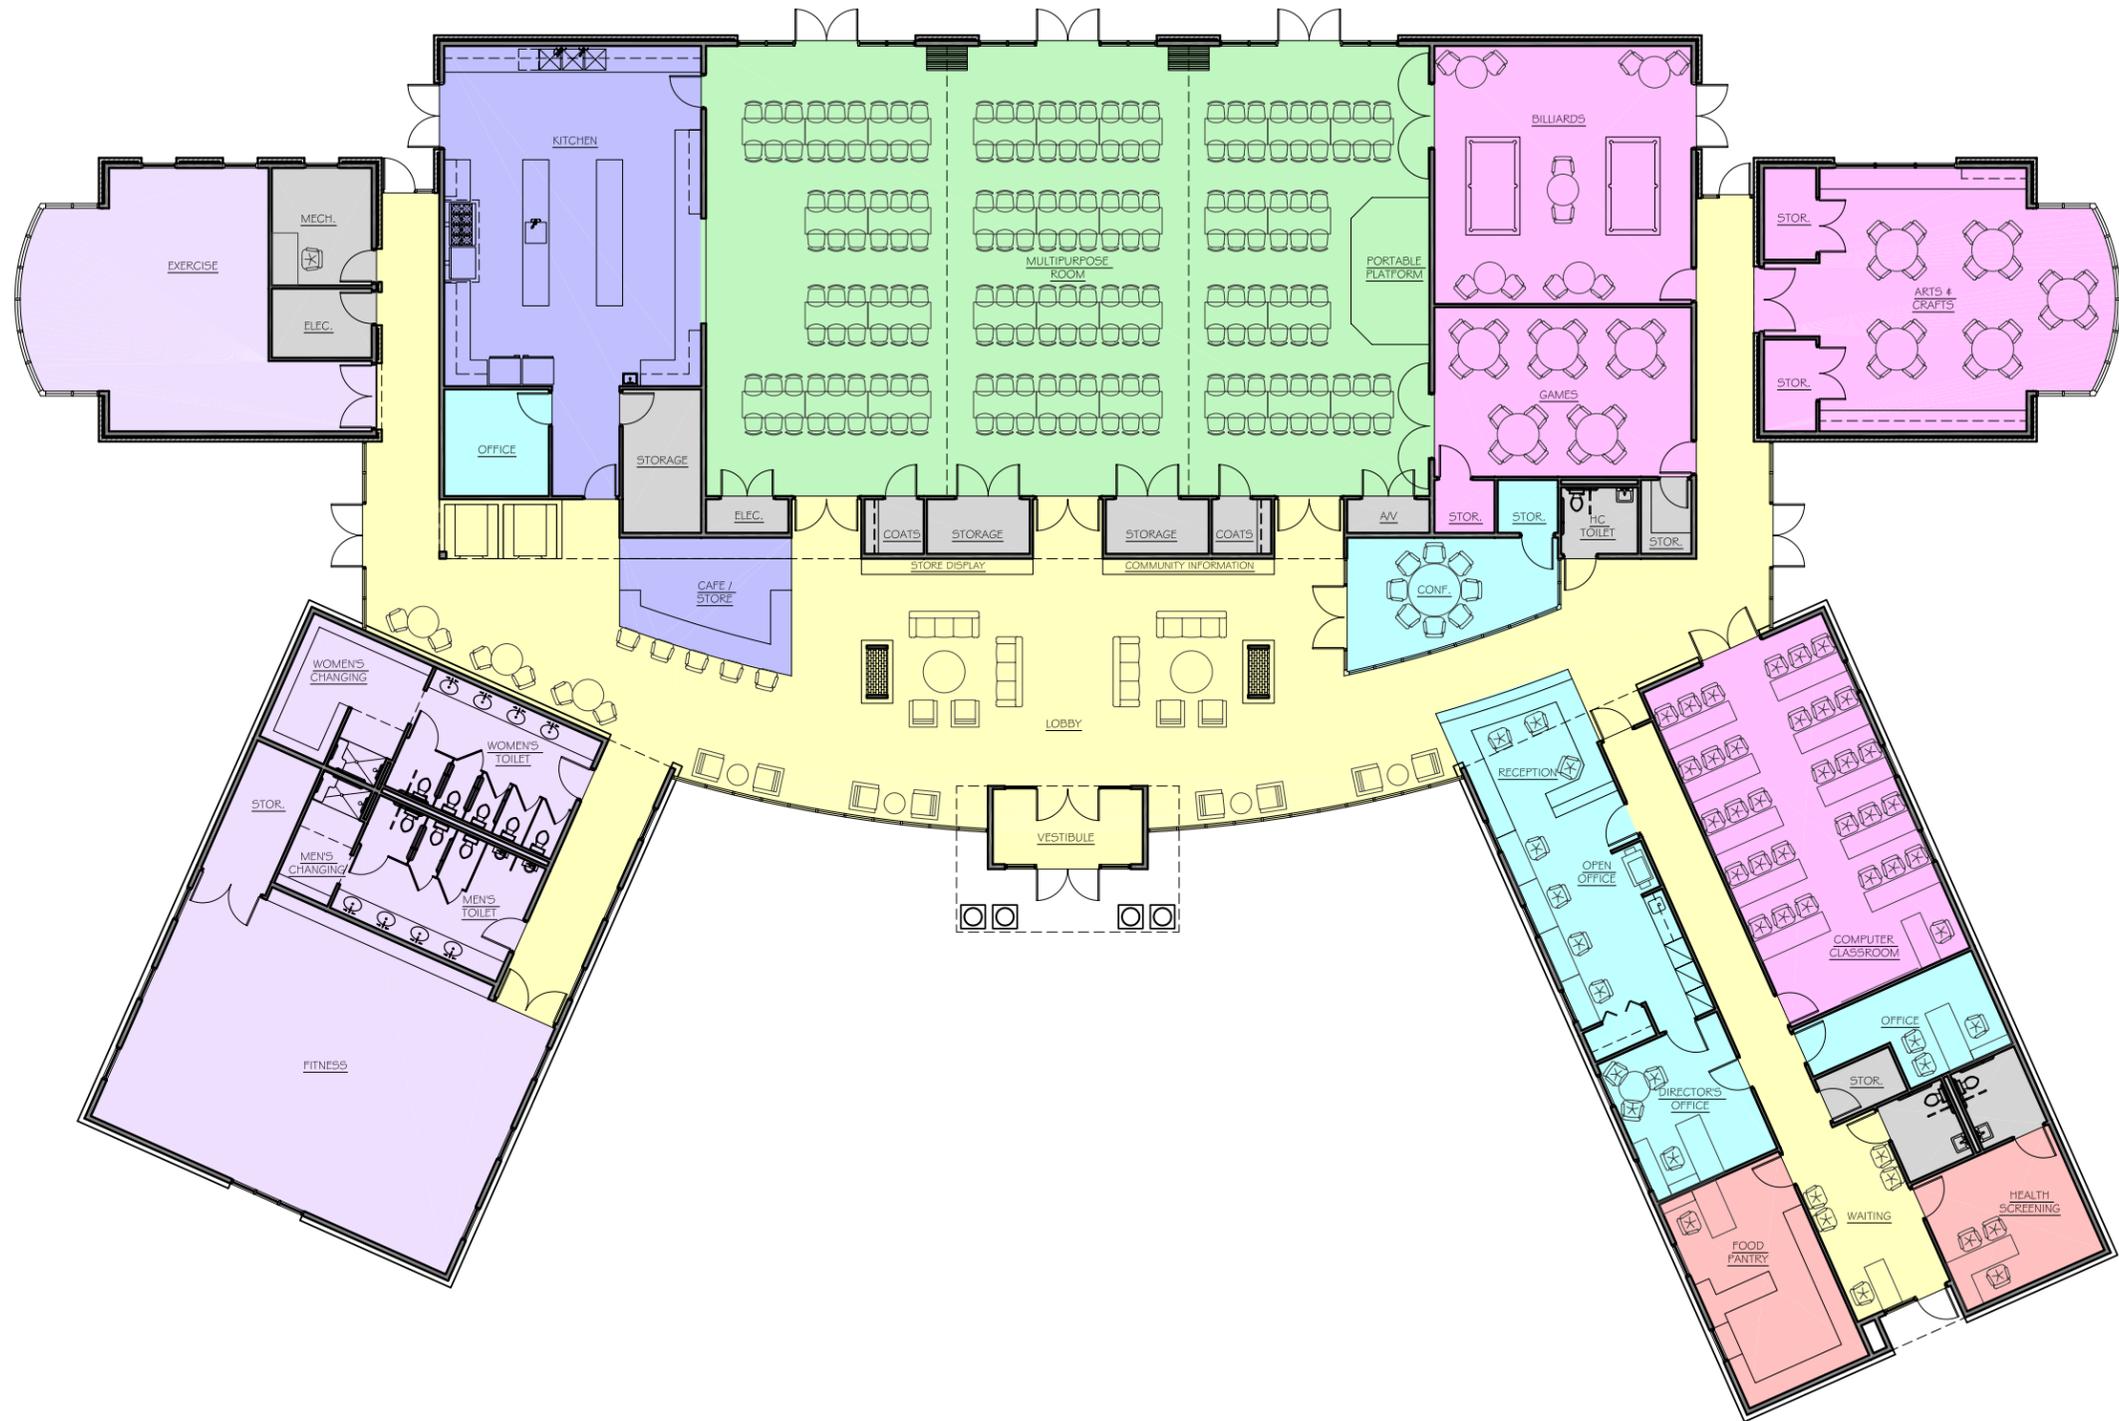
Yellow	LOBBY
Cyan	ADMINISTRATION
Pink	ACTIVITY SPACES
Red	SPECIAL SERVICES
Green	MULTIPURPOSE
Blue	KITCHEN / FOOD SERVICE
Purple	EXERCISE / FITNESS
Grey	SUPPORT SPACE

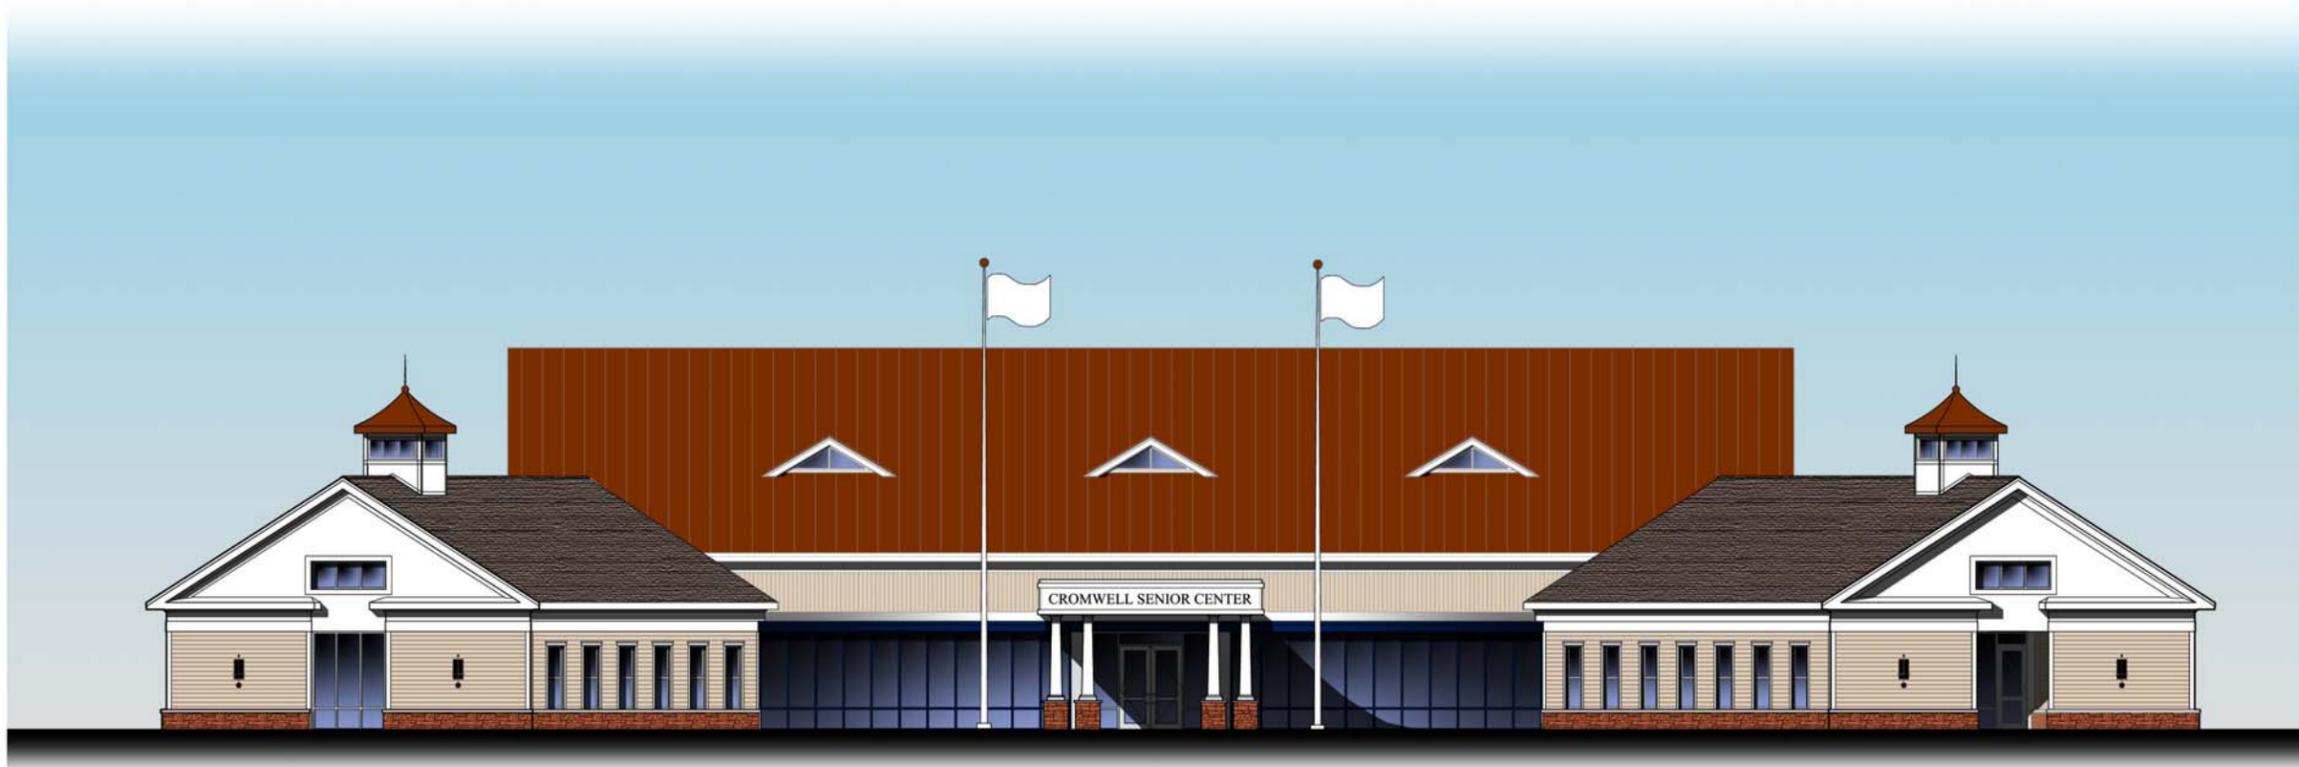
FRONT ELEVATION

SCALE: 1/8" = 1'-0"

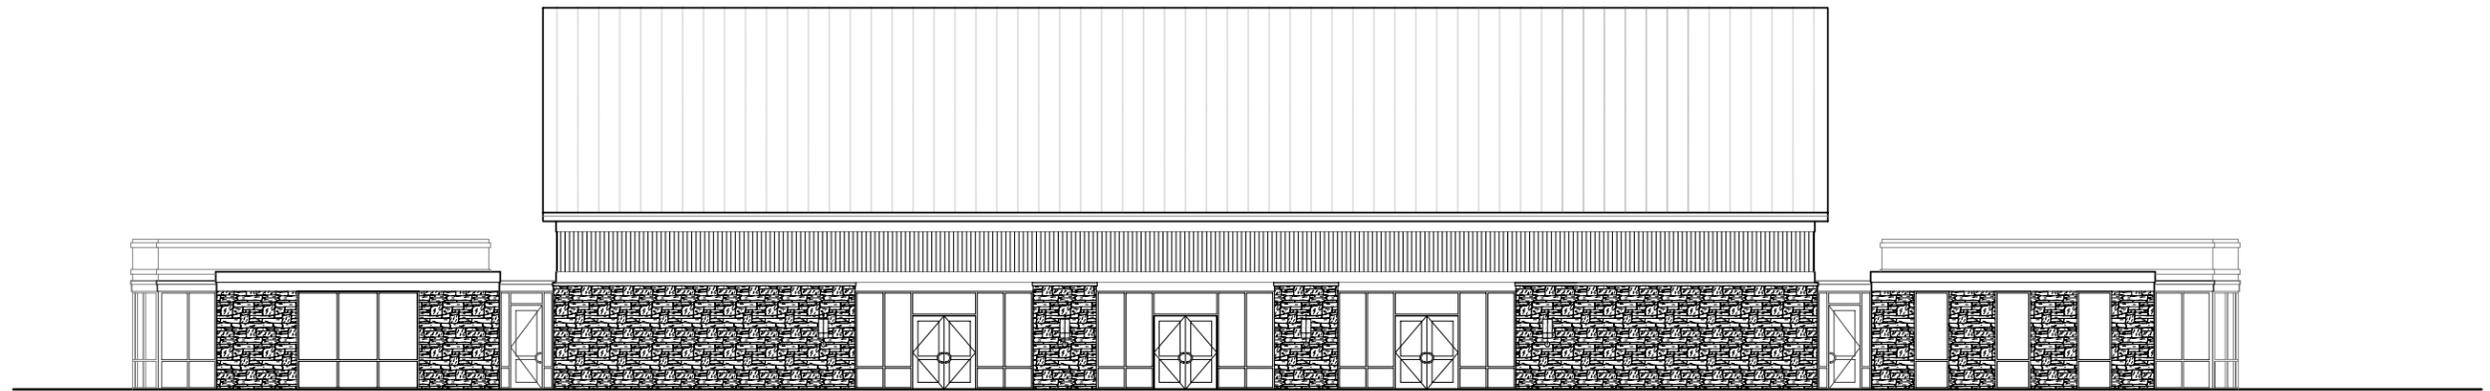
REAR ELEVATION

SCALE: 1/8" = 1'-0"

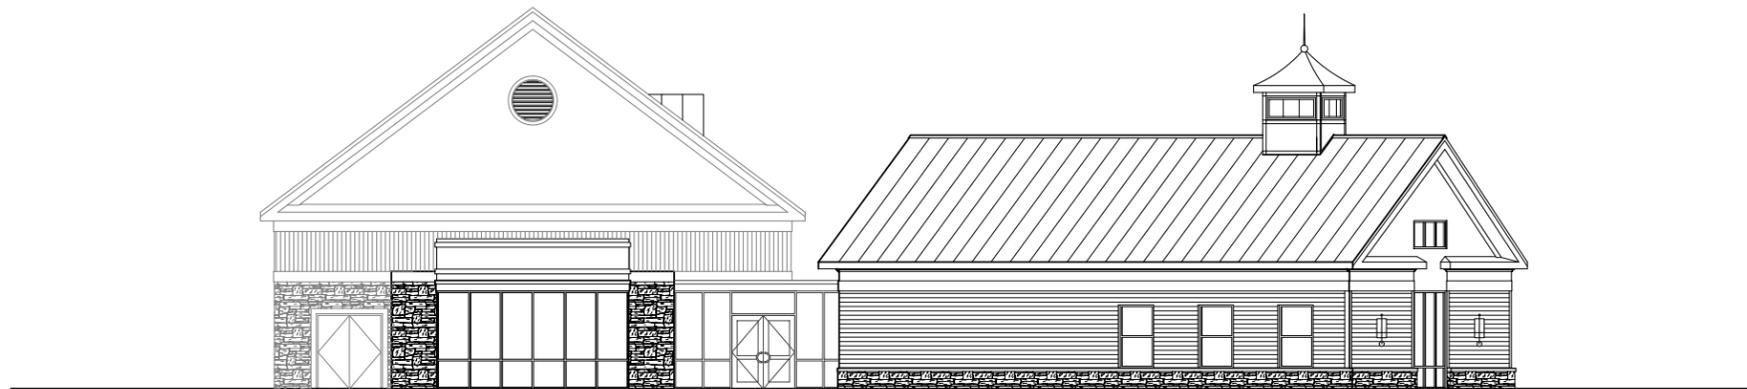
LEFT SIDE ELEVATION

SCALE: $\frac{1}{8}'' = 1'-0''$
