# CROMWELL TOWN HALL SENIOR CENTER, 19 COMMUNITY FIELD ROAD & 20 JAMES MARTIN DRIVE FEASIBILITY / SPACE NEEDS STUDY

## Phase 1: Former Public Works Garages Assessment Report

8/11/2021

SILVER / PETRUCELLI + ASSOCIATES

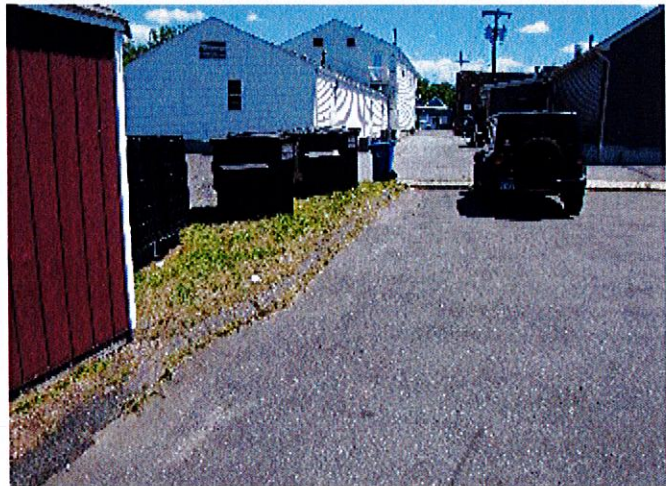
Figure 4

The minor amount of landscaping, which is located east of the facility, between the parking lots, is not maintained and it is utilized as a location for several dumpsters (Figure 4). While this is used by the Police Station, future site programming should account for dedicated dumpster pad locations and enhanced landscaping for both buildings to utilize.

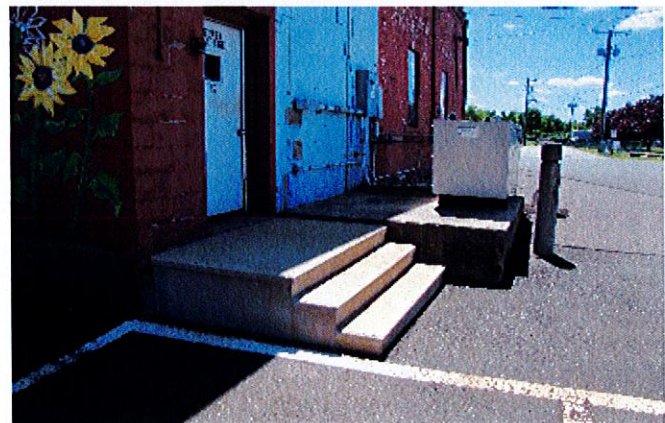
Figure 5

The pedestrian doors (front and rear) are not flush with the adjacent bituminous pavement and therefore do not meet accessibility requirements (Figure 5). If the building were to be reused, one of the doors would require site renovations to provide accessibility.

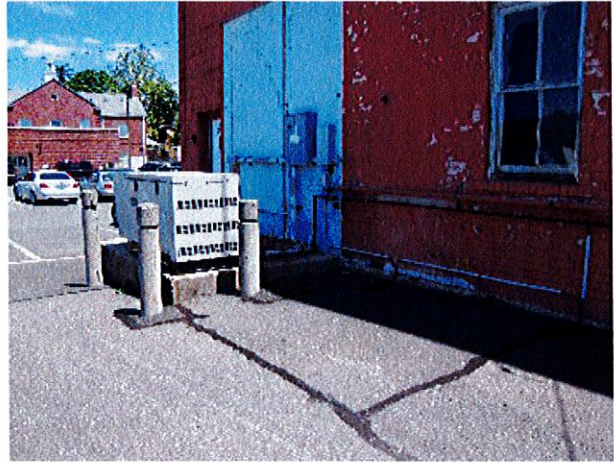
*Figure 6*

There is a raised concrete pad adjacent the front door on the west side. (Figure 6) Although it exhibits some minor deterioration, the pad and associated bollards appear to be functional and in working condition.

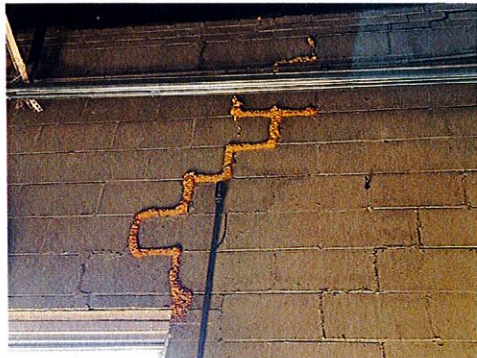
The interior walls are CMU and brick with limited sheet rock walls. The CMU and brick need repairs as the stepped cracking is evident inside the building as it was on the outside. Some have foam insulation sprayed in between them. After repairing these cracks, furring out walls the with insulation and sheetrock may be the best option to create a finished more energy efficient space. Some other walls are constructed out of plywood and sheetrock.

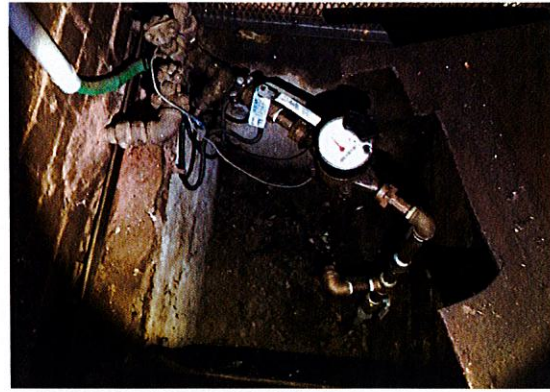
Water meter in pit

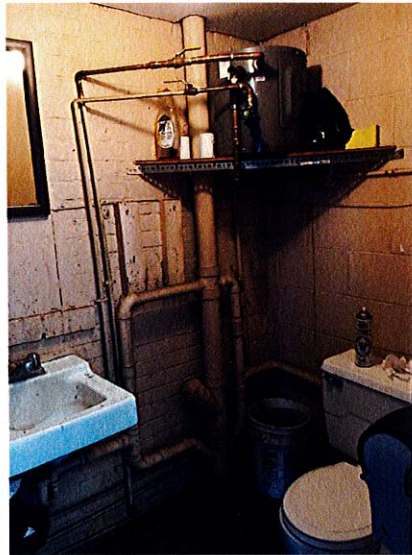
Water heater; uninsulated piping

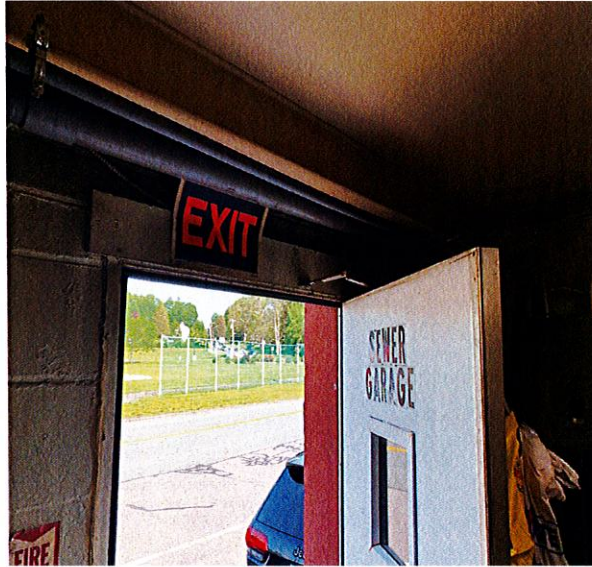
Although there is an existing standby generator backing up the entire building, emergency relays to suit emergency lighting and additional emergency lighting source required by code were not observed throughout the building. Egress exit signs are paper and not self-luminous. Illuminated exit signs are highly recommended to comply with code in any future project.

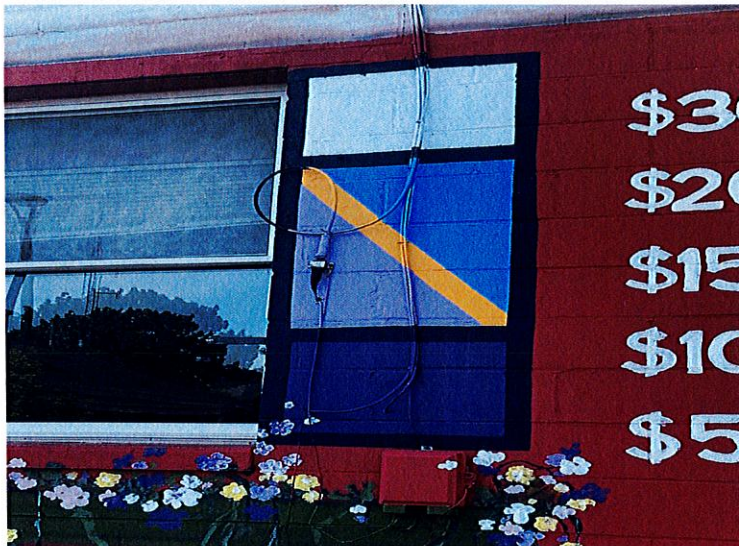
The communication system is based on an overhead connection from a utility pole located at Community Field Road and terminated at a utility Dmarc<sup>1</sup> located at the exterior wall. The Dmarc is connected to a punch-down terminal located inside the building. The Dmarc, punch-down block and infrastructure are obsolete and should be replaced with a new system. No data network system was observed.

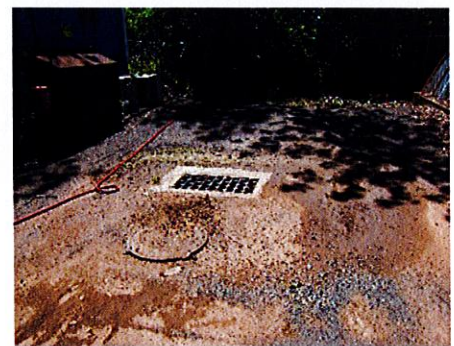
Figure 3

There are two (2) drainage structures located on the north side of the facility. It is unclear if they are catch basins or dry wells. Both were inundated with sediment. The structure just northwest appeared to be clogged as it was filled with water (Figure 1) and the structure just to the northeast was dry. The structure tops had minor cracking but appeared to be functional. Both should be cleaned, with the sediment removed, and the inside inspected for structural integrity.

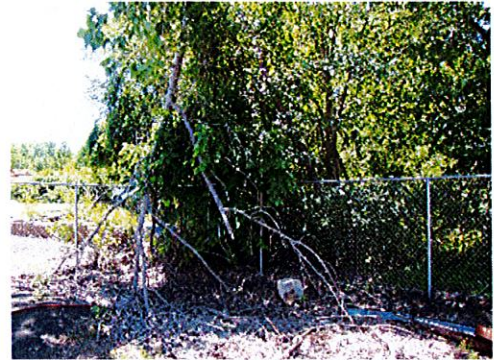
Figure 3

The site is bordered on the south by a fence adjacent a retaining wall, separating it from the adjacent site (Figure 2) and to the east separating it from the playing field, both of which appeared to be functional although there are a couple sections that need replacement. There is also a fence directly behind the facility to the west (Figure 3) that appears to be functional, but it has trees and landscaping growing through it.

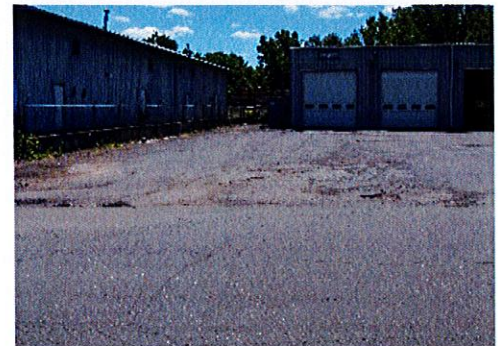
Figure 4

The pavement is in disrepair and requires replacement. Depending on the nature and depth of the existing base material, as well as the proposed site grading for a future site renovation, the pavement will require mill/overlay, full depth replacement or in-place reclamation (Figure 4). In addition to the dependency on the proposed grading, the type of pavement renovation can be determined by performing several test pits to determine the depth of pavement and base material, and the testing of the base material for grain size analysis.

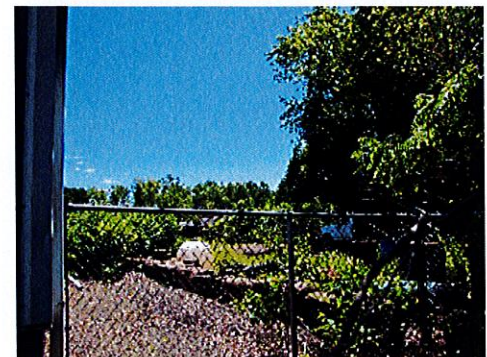
Figure 5

The landscaping behind the facility on its west side is overgrown and not maintained (Figure 5). Depending on future site programming behind the building, this can either be cleaned up and maintained, or it can be replaced with new landscaping.

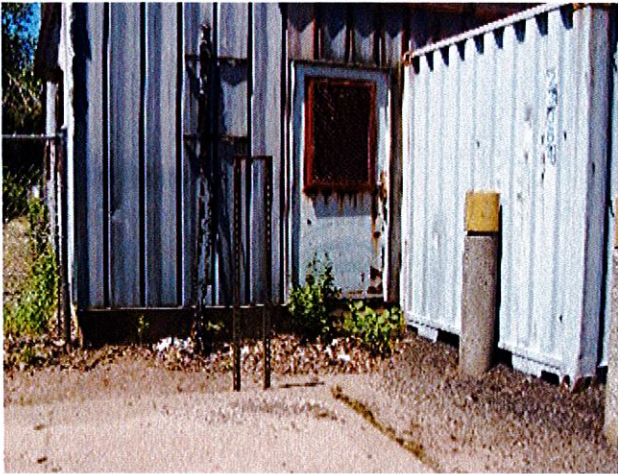
*Figure 6*

The pedestrian doors are not flush with the adjacent bituminous pavement and therefore do not meet accessibility requirements (Figure 6). If the building was to be reused, the grade of any new pavements or walkways should be raised to be flush with the pedestrian doors.

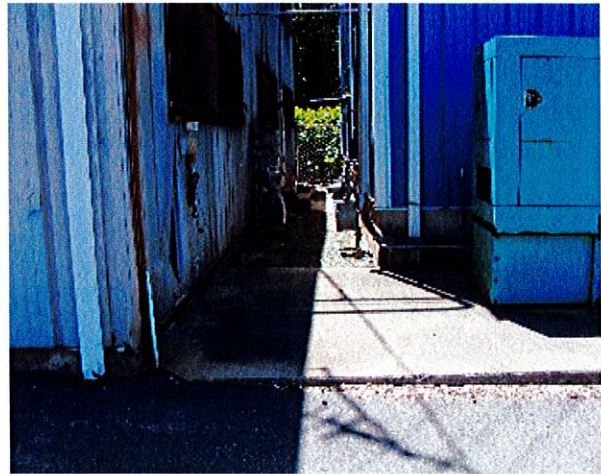
*Figure 7*

There is a concrete pad adjacent the southwest and northeast portions of the facility, both of which exhibit signs of slight deterioration (Figure 7). The pad on the southwest portion of the site should be demolished and removed. Depending on the future programming, if the concrete pad on the northeast portion of the building was to be reused, it could potentially be repaired using appropriate concrete repair materials.

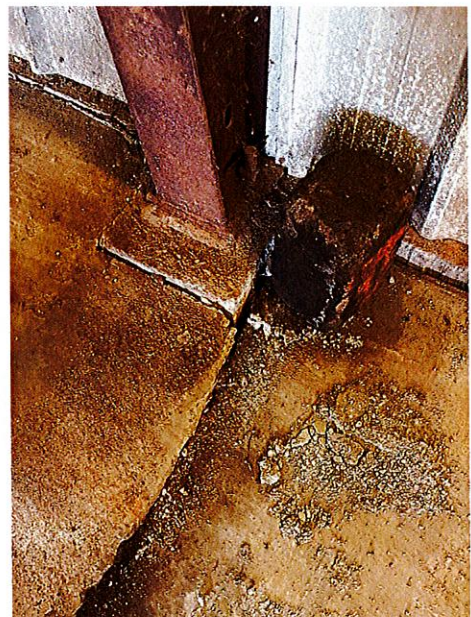
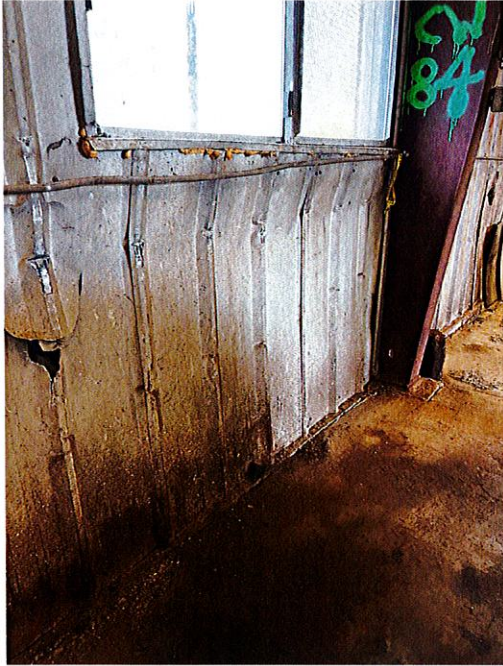
The floors are a variety of materials. The main level consisting largely of the apparatus bays, are a bare concrete slab. Accessory spaces on the lower level such as the lavatory and office rooms are also an exposed concrete floor. There is cracking and staining throughout much of the areas. Most notably, the western portion of the floor has seen evident settling. It apparently has been attempted to be corrected in the past with an overlay slab on top. However, there is still a significant change in elevation due to the movement and settlement. The route of the problem will need further evaluation and the slab will need some significant work to be converted to a space that will require finished level flooring. A geotechnical engineer should be retained to further evaluate the cause of this issue. If corrected and converted to other uses, floating a floor on sleepers over the concrete slab will be the best option for getting a finished floor to adhere.

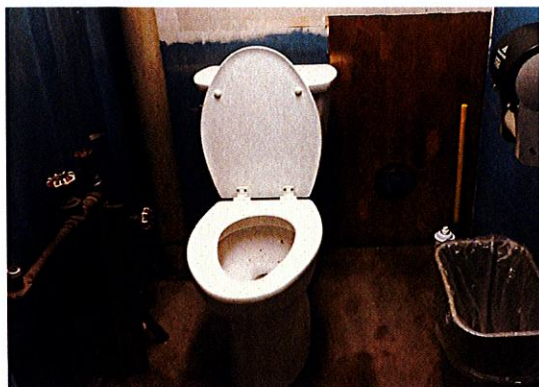
Domestic water from piping below floor

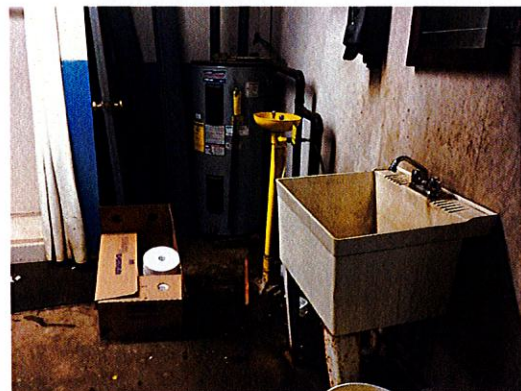
Domestic water was heated by a (2014) American Water Heater Proline, 40 gallon electric water heater, located in the first floor toilet room. The electric water heater does not have hot water recirculation. The current code-required thermal expansion tank and ASSE1017 mixing valve were not found.

Water heater, emergency eyewash and Service sink

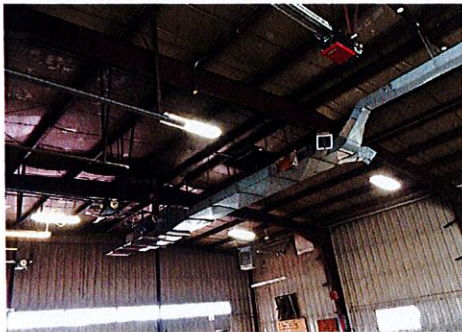
Ducted oil fired furnace

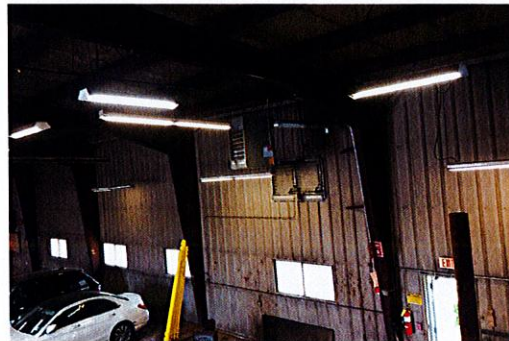
Gas fired unit heater

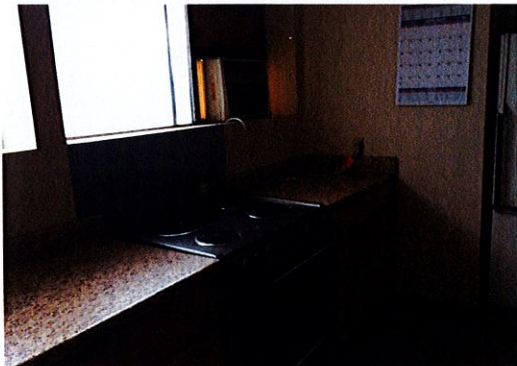
The second floor kitchenette is provided with window mounted air conditioning unit and a ceiling mounted exhaust fan. There is no exhaust hood above electric range.

Kitchen range with no exhaust hood

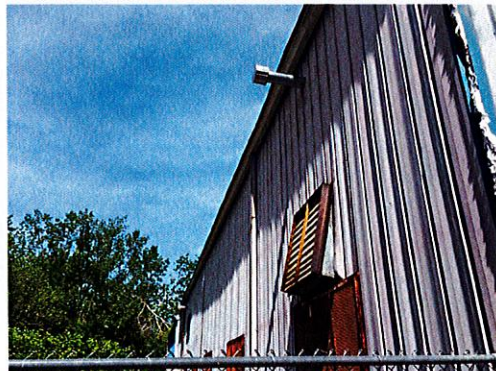
Outdoor air intake louver and gas fired unit heater flue piping

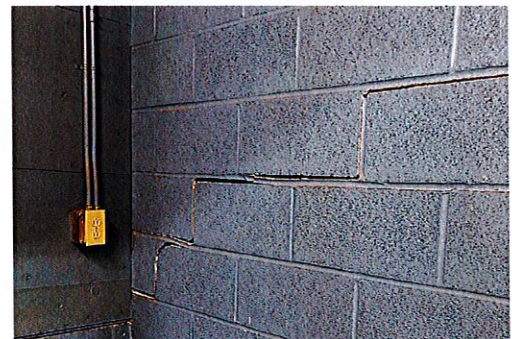
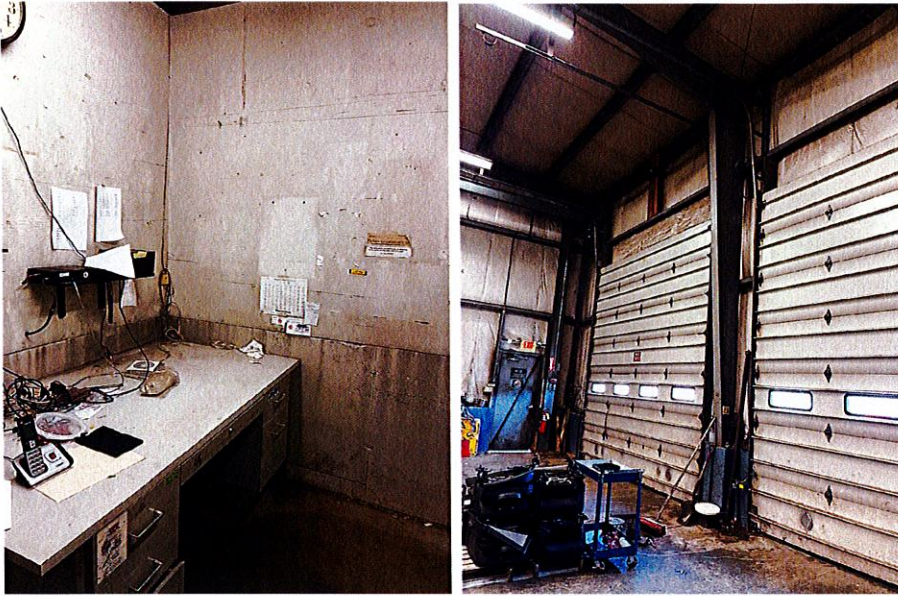
The walls throughout the facility are a variety of materials. On the interior of the exterior walls, there is no finished system. Instead, the insulation is exposed and sits on top of the painted foundation walls. Due to the nature of the space some of these areas are damaged, stained, and dirty. Most interior walls are constructed from concrete masonry units (CMU) while some are painted, and others are bare. These walls are in fair

condition with some areas of stepped cracking at the mortar joints. Other walls are constructed with plywood, and some are painted, such as in the office on the lower level. These are in fair condition. On the mezzanine level there are wood stud walls. At the restroom, these walls have a painted gypsum wall board (GWB) finish while other spaces are not painted or have no GWB at all.

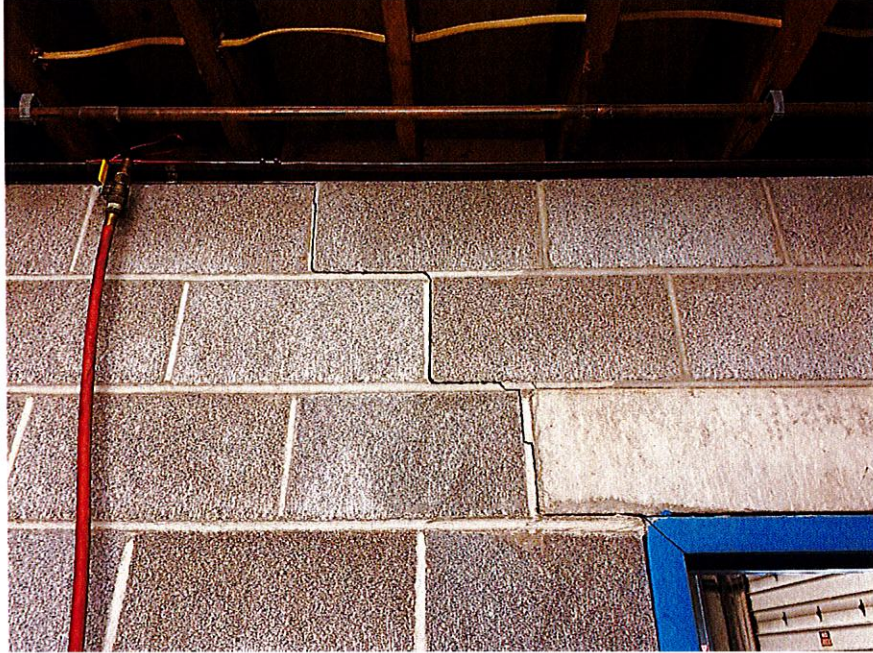
The interior walls of the office at the ground floor level are load bearing CMU partitions, supporting the mezzanine framing above. The interior walls above the mezzanine level are wood studs. Some cracking of the CMU partitions was observed.

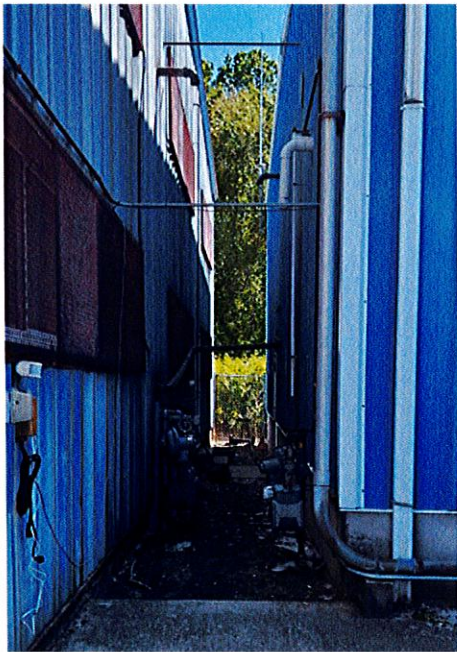
The gas service is routed underground to the exterior east wall of the building, where the service pressure regulator, gas meter, and building pressure regulator are located. Gas is distributed to the gas furnace in the building, using black steel pipe. Exterior gas piping is exhibiting surface corrosion.

Gas meter and sanitary pipe location

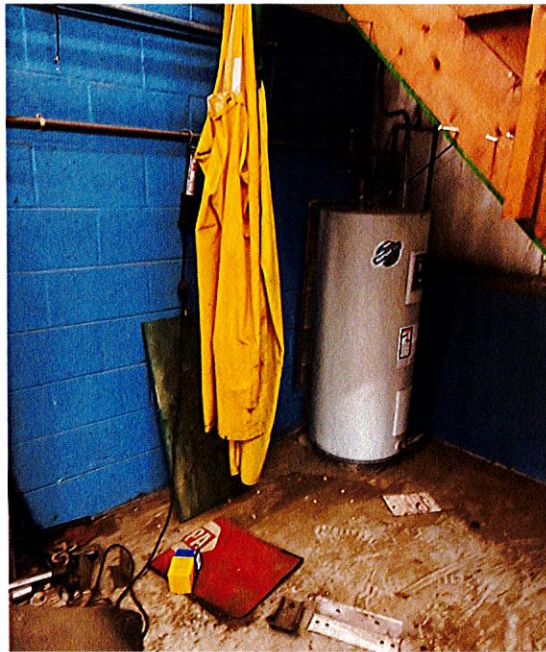
Domestic water was heated by a (2011) Bradford White Corporation, 40 gallon electric water heater, located in the mechanics bay below the stairs. The electric water heater does not have hot water recirculation. The current code-required thermal expansion tank and ASSE1017 mixing valve were not found.

Water heater; uninsulated piping

If the building is converted to other use such as Business or Assembly, all existing piping distribution, plumbing fixtures will be replaced and all industrial related fixtures, equipment and associated piping will be removed. The domestic hot water heater is at the end of its useful service life and is recommended to be replaced. The new heater will be provided with required expansion tank, mixing valve and recirculating pump, to accommodate the new occupancy needs.

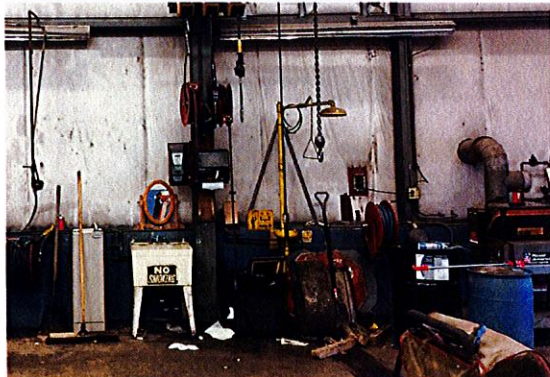
Emergency Shower/Eyewash

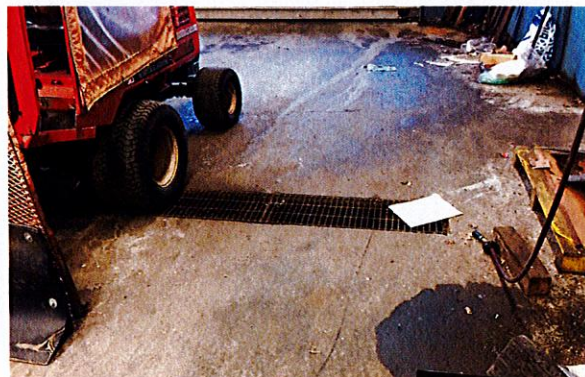
Non-accessible trench drain grate (ADA requirement: 1/2" gap limit perpendicular to direction of pedestrian travel.

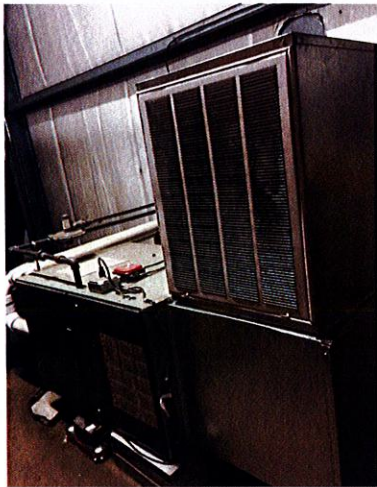
Gas fired furnace serving the Building

If the building is converted to other use such as Business or Assembly, the existing high efficiency gas furnace, at approximately 4 years old, can be reused. It is recommended to clean the heat exchanger thoroughly to remove any dirt and contaminants accumulated while being used in industrial setting. It is recommended to replace the duct distribution system with new. Additional HVAC systems will be provided for thermal comfort and acceptable indoor air quality.

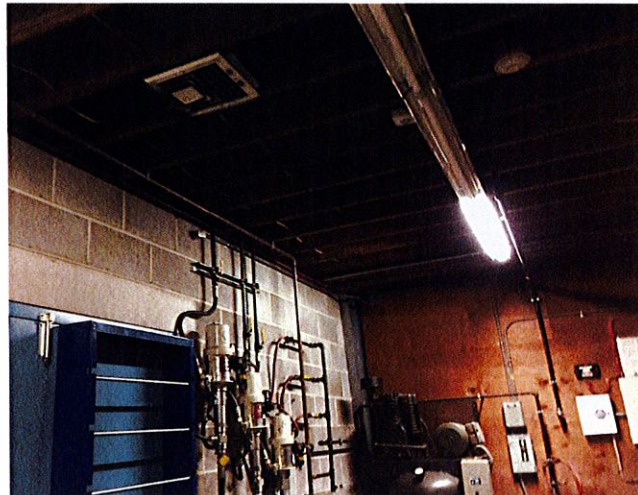
The first floor mechanical room heating is provided from the building gas fired furnace. There is no exhaust provided.

First floor mechanical room

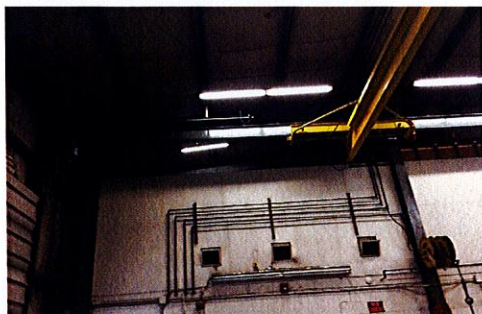
Sidewall supply registers serving Bay

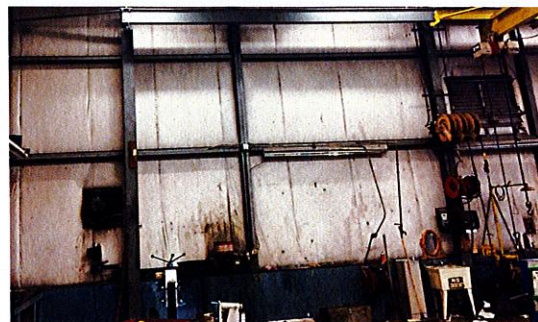
Wall exhaust fan and outdoor air intake louver
